# UNIVERSITY OF CINCINNATI

**ENGINEERING GEOLOGY AND RELATIVE STABILITY  
OF GROUND ADJACENT TO  
SAWYER PLACE  
CINCINNATI, OHIO**

**MASTER OF SCIENCE**

1988

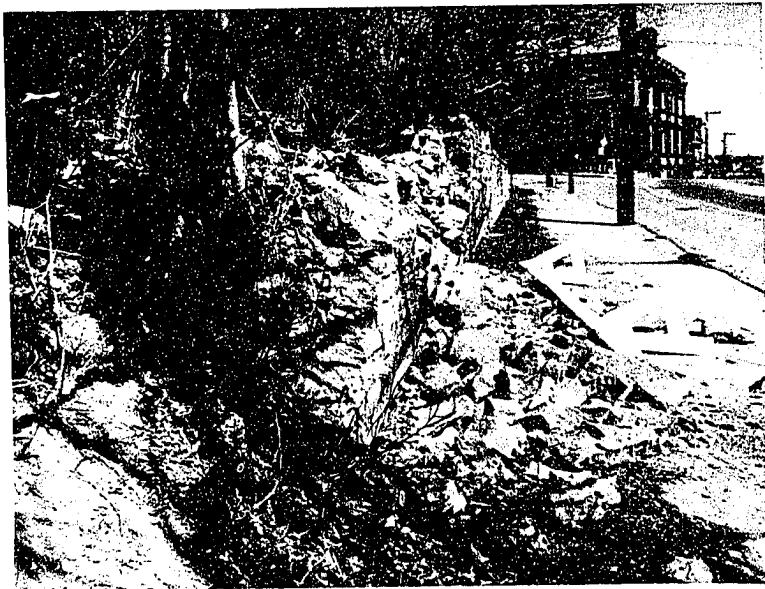
Frontispiece. Destruction of retaining wall by shallow landsliding in the Sawyer Place area. (Photo by Robert Olson, 1988).

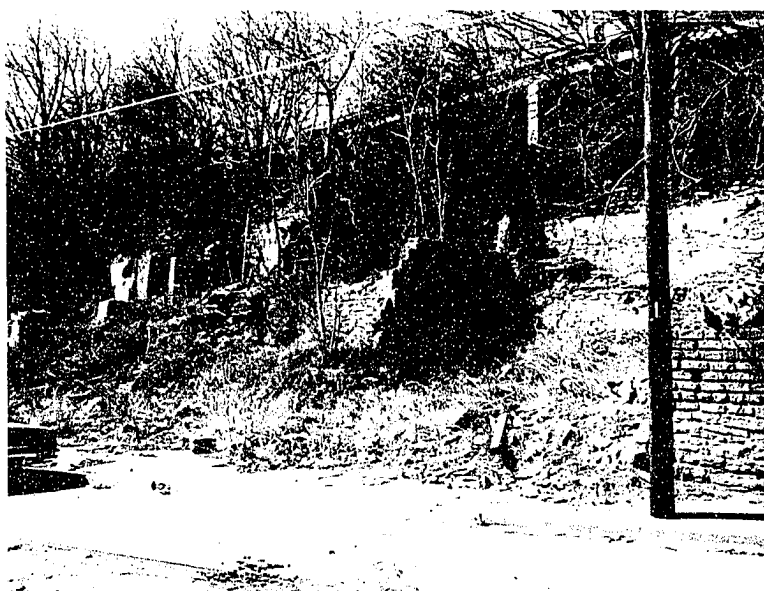
The part of the Sawyer Place area from I-471 to Bains Street shows the least amount of landsliding (Plate I). Most landslides in this area are shallow, inactive and isolated from each other. Failures are localized and disrupt older retaining walls and foundations, as on Martin Street (Fig. 14).

Figure 14. Razed housing along Martin Street. (Photo by Robert Olson, 1988).

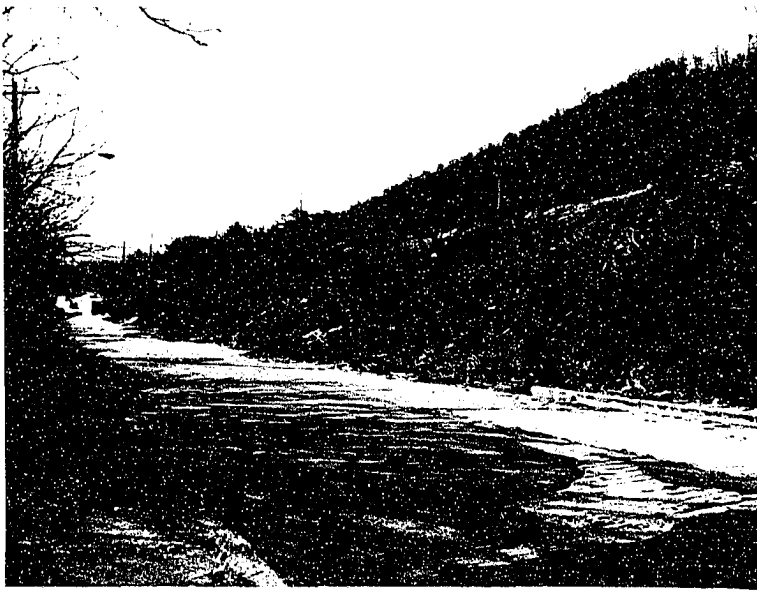
The area between Bains Street and Kemper Lane is transitional from dormant, inactive landslides into large, active deep landslides. Houses bordering Columbia Parkway and Eastern Avenue have been razed. A large deep landslide begins just east of Bains Street, where it is mostly inactive, to Kemper Lane, where it is active. The head scarp occurs in fill which forms the embankment of Columbia Parkway, and reaches within a few metres of the Parkway. The toe intersects the sidewalk, and overrides Eastern Avenue and Kemper Lane (Figs. 15 and 16).

Figure 15. Encroachment of soil from deep landslide onto Kemper Lane results in disruption of roadway and rotation of sidewalk. (Photo by Robert Olson, 1988).

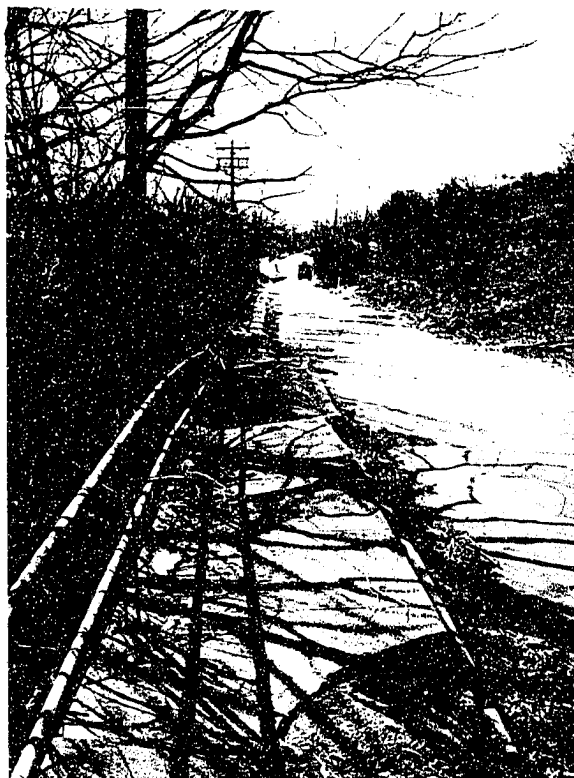
Figure 16. Broken sidewalk on Kemper Lane caused by deep landsliding. (Photo by Robert Olson, 1988).

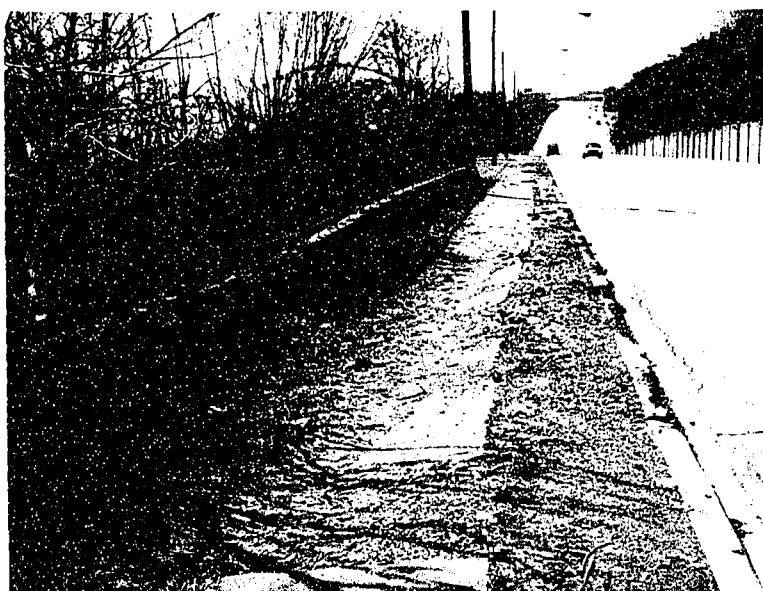
There is failure in Columbia Parkway and the sidewalk above Weeks Street (Fig. 17). A large excavation was made in a deep-seated landslide for two school buildings on weeks street. The result of the excavation was numerous cracks and severe bowing of the retaining wall behind the buildings directly below the Columbia Parkway. One of the school buildings has been razed (Figs. 18 and 19).

Figure 17. Bowing sidewalk and retaining wall caused by deep landslide movement under Columbia Parkway at Weeks Street. (Photo by Robert Olson, 1988).

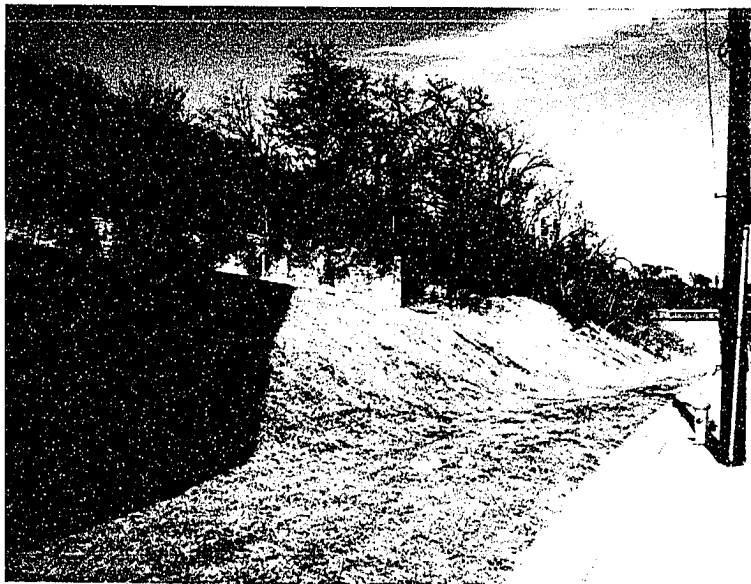
Figure 19. Bowing sidewalk of Avenue caused by previous movement of toe of deep landslide in front of excavated toe. (Photo by Robert Olson, 1988).

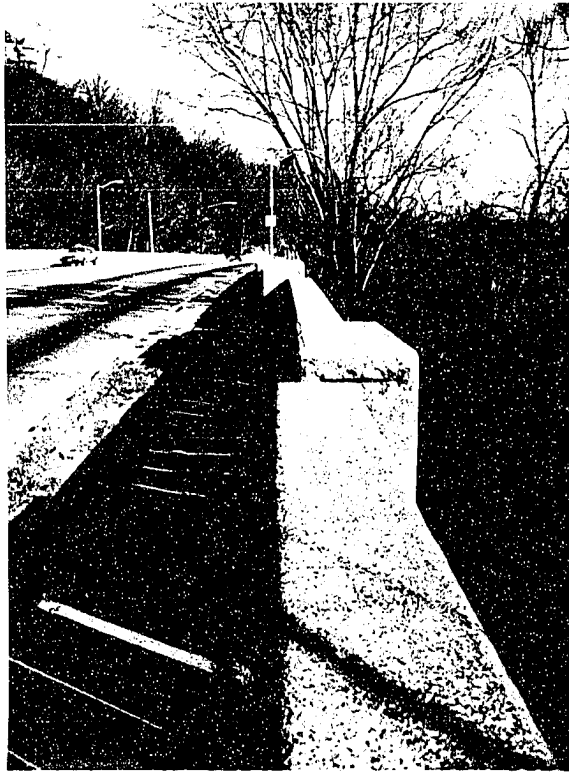
Figure 21. Right lateral shear of 20 cm in Columbia Parkway bridge at Kemper Lane. (Photo by Robert Olson, 1988).

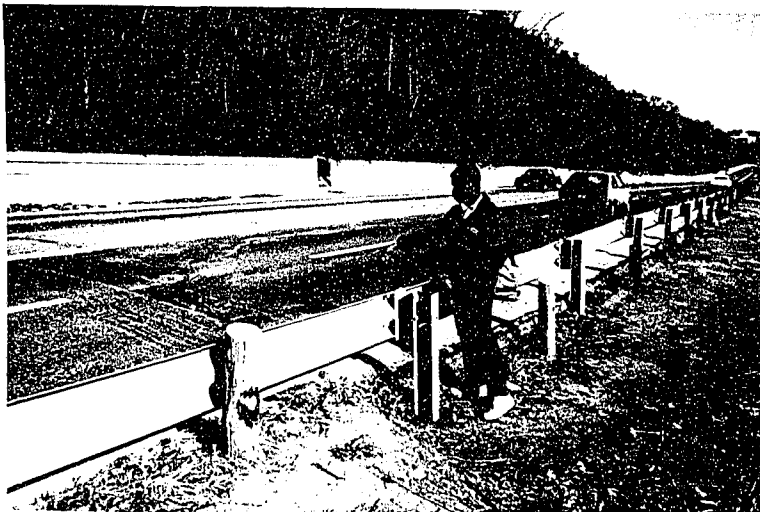
Landslides above the parkway are deep and active east of the intermittent stream valley and beneath the new high-rise residences along Grandview Avenue and Salutaris Avenue (Plate I). The outer, east-bound lanes of Columbia Parkway are distressed due to landsliding between Lancaster Street/ Salutaris Avenue and Collins Avenue (Fig. 22).

Figure 22. Headscarp cutting through pavement of Columbia Parkway (note vertical displacement of roadway at Brian's feet). (Photo by Robert Olson, 1988).

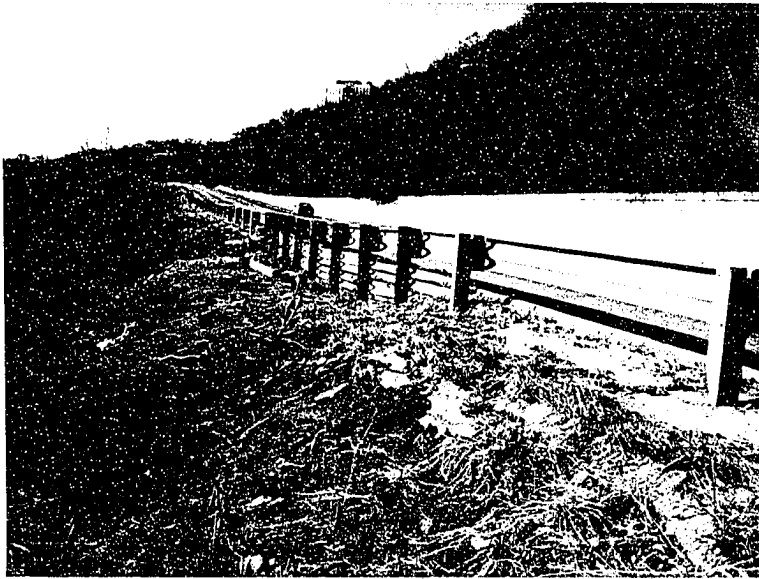
Deep landslides continue above the parkway and under the high rise residences where foundations and roadways have been destroyed. Makeshift repairs to the parkway necessitated by deep landsliding have failed, showing that landslide activity continues (Fig. 23).

Figure 23. Makeshift repairs to the pavement of Columbia Parkway as a result of landslide movement. (Photo by Robert Olson, 1988).

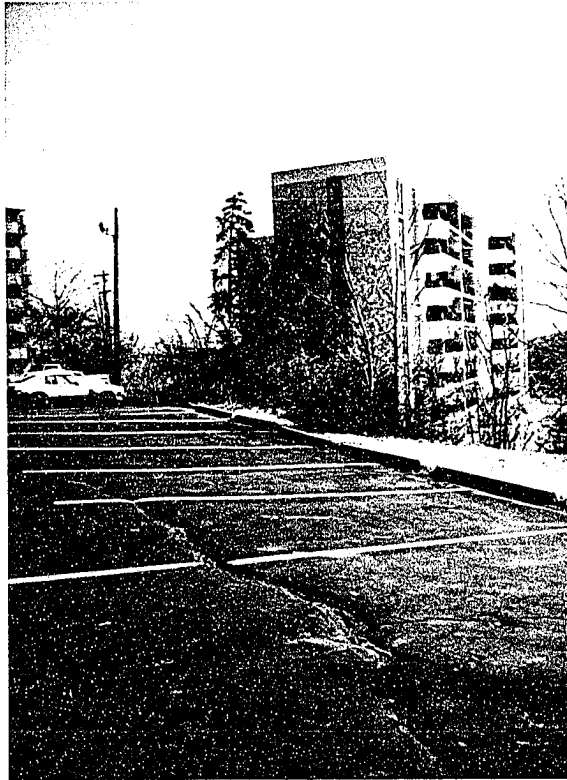
A deep landslide exists above the parkway, 150 metres west of Collins, where half of the slide has been excavated and a high-rise residence constructed. Although movement within the remainder of the landslide is small, new tensional cracks of 16 centimetres wide have appeared in the parking lot directly above the existing half of the landslide (Fig. 24).

Figure 24. Tensional Cracks in pavement of parking lot located above deep landslide at Bond Place. (Photo by Robert Olson, 1988).

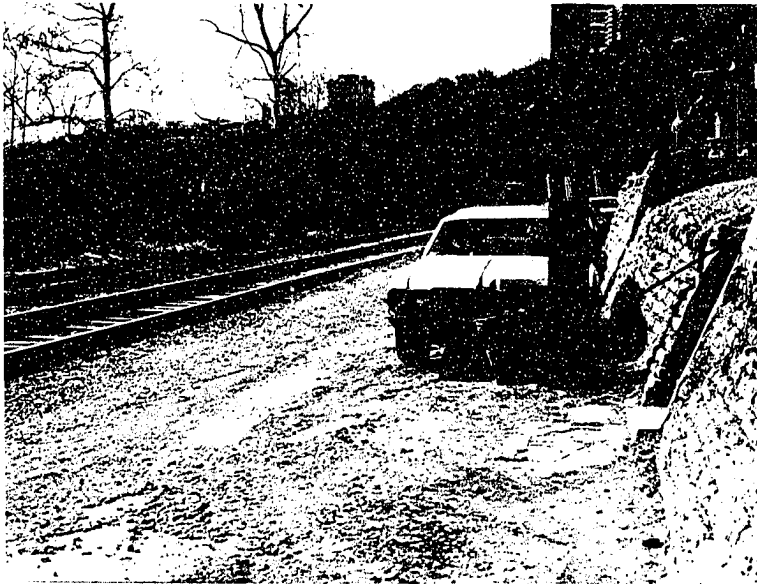
Figure 25. Bowing and rotation of retaining wall caused by deep landsliding under gladstone. (Photo by Robert Olson 1988).

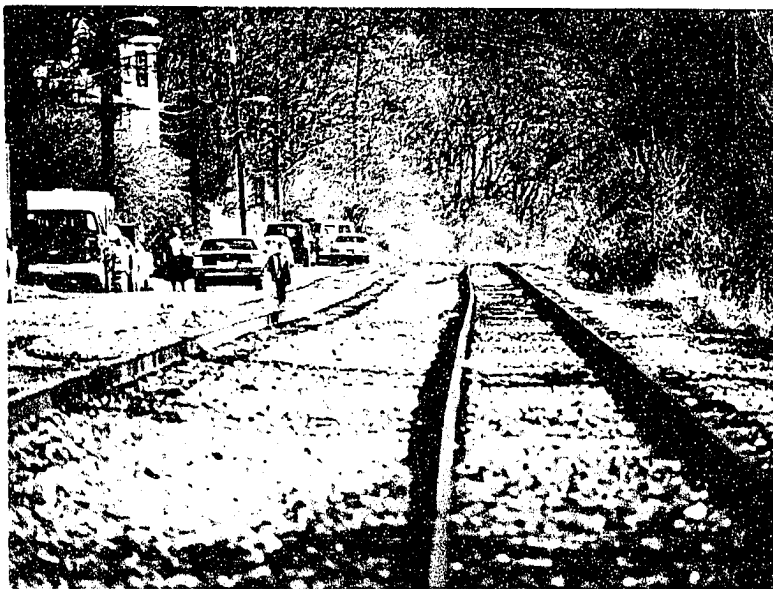
Figure 26. Warping of Conrail tracks by deep landsliding under Gladstone. (Photo by Robert Olson, 1988).

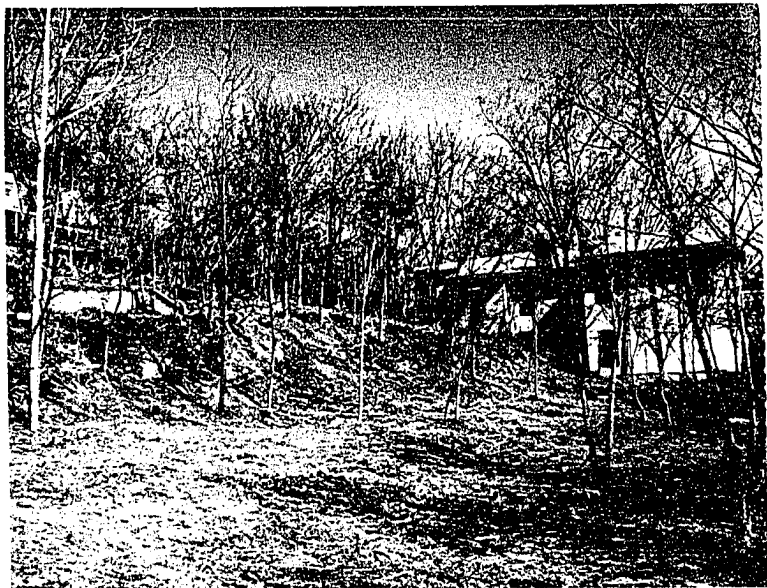
Figure 27. Toe of deep landslides under Gladstone. (Photo by Robert Olson, 1988).

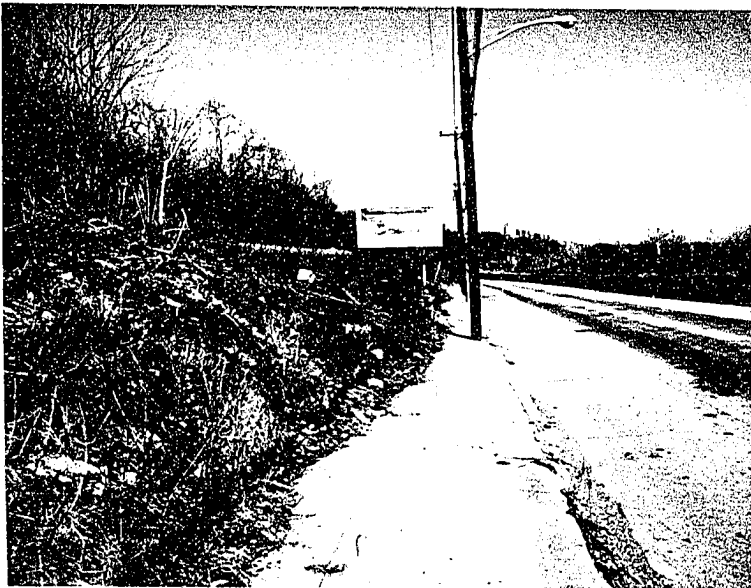
Creep causes disruption of walls and soil encroachment over sidewalks in the area between I-471 and Bains Street. Most notable examples of creep are downslope from Martin Street, Parsons Street and Whittaker Street (Fig. 28). Small trees on the slopes of Riverview Playground are rotated by soil creep.

Figure 28. Soil creeping over retaining wall onto sidewalk of Eastern Avenue at Parsons. (Photo by Robert Olson, 1988).
