*It is entitled* LAND USE AND LANDSLIDING IN  
PRICE HILL, CINCINNATI, OHIO

**LAND USE AND LANDSLIDING IN PRICE HILL,  
CINCINNATI, OHIO**

**TIM J. AGNELLO**

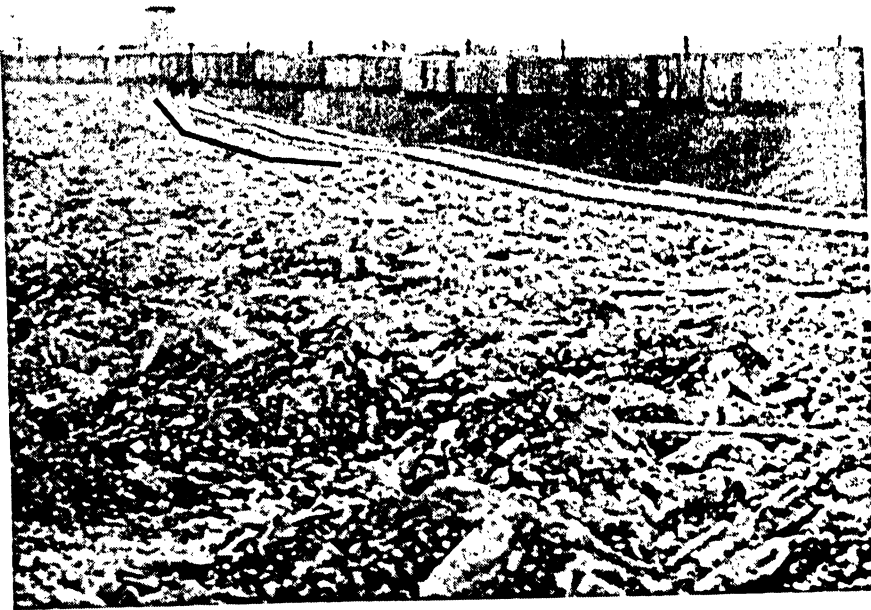
**Figure A.5** Bald Knob fill dominates this photograph. Note the railroad tracks are disrupted in the area outlined due to embankment failure. Photograph from the George Stowitts collection (1929-1933).

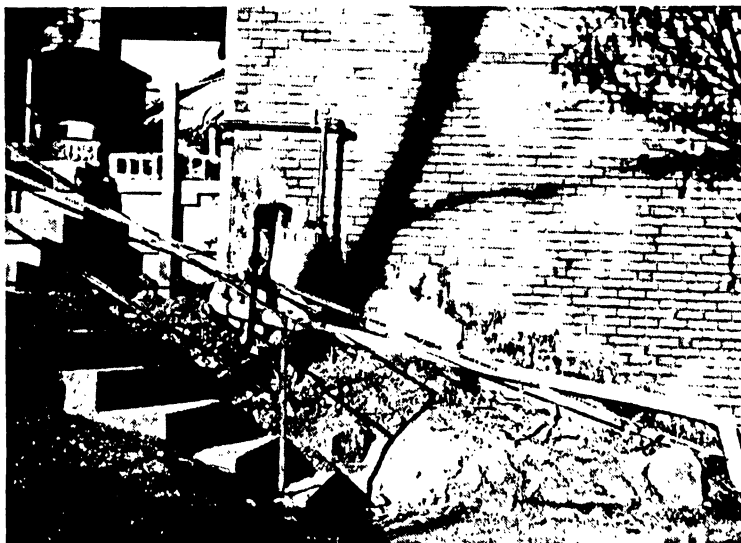
**Figure A.8** Water main break at the West View Condominium. The water main break caused the ground adjacent to the building to drop several inches and the down slope soil to bulge.

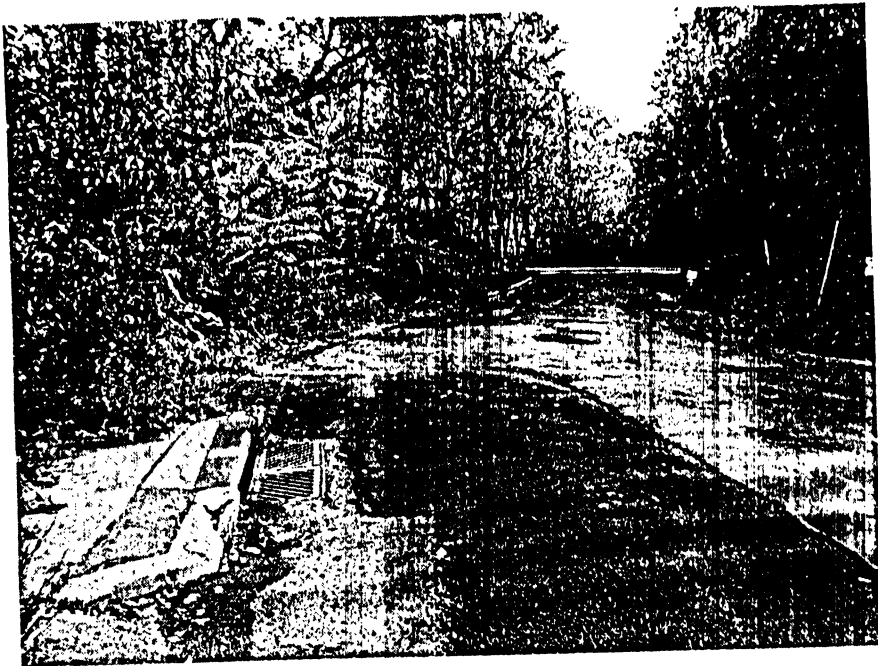
The upper portion of Maryland Avenue past the incline abutments has been closed to vehicular traffic due to slope movement that occurred in 1987 (Pohana, 1991). The preexisting landslide caused the water main break, which further damaged the eastern downhill side of Maryland Avenue. The eastern side of Maryland Avenue asphalt is overly thick (>18 inches) indicating long-term patching and movement of the hillside below Maryland Avenue. A scarp cuts through and defines the eastern edge of Maryland Avenue. The surficial deposits below Maryland Avenue are predominantly fill, with the toe of the slide just above the wall on Warsaw Avenue. This landslide is contiguous with the landslide mapped immediately north of and just below the upper bend in Maryland Avenue.

**Figure A.9** Upper Maryland Avenue closed off to vehicular traffic to due a break in the water main that accelerated the preexisting landslide. Note the asphalt patch on the down hill side of the road.

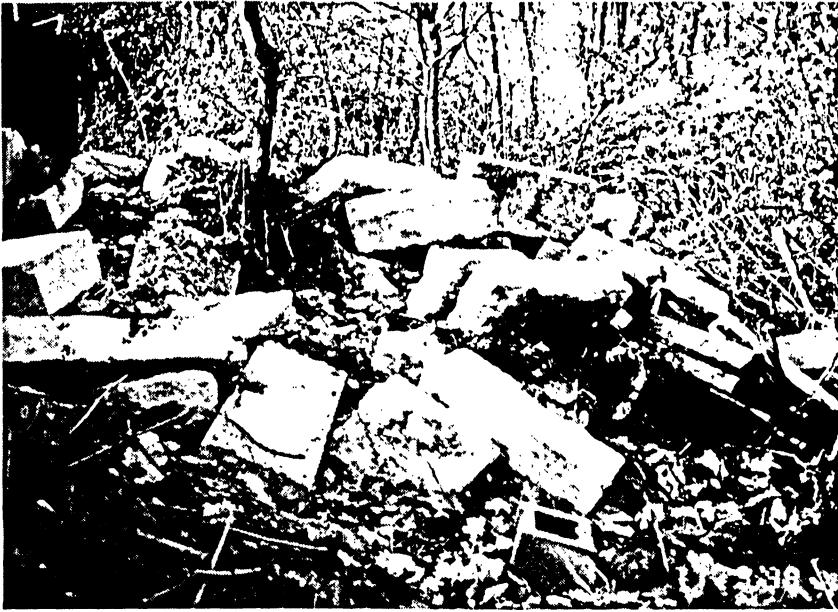
**Figure B.2** Concrete debris dumped by a contractor or maintenance personnel load the hillslope below the West View Condominiums above Glenway Avenue.

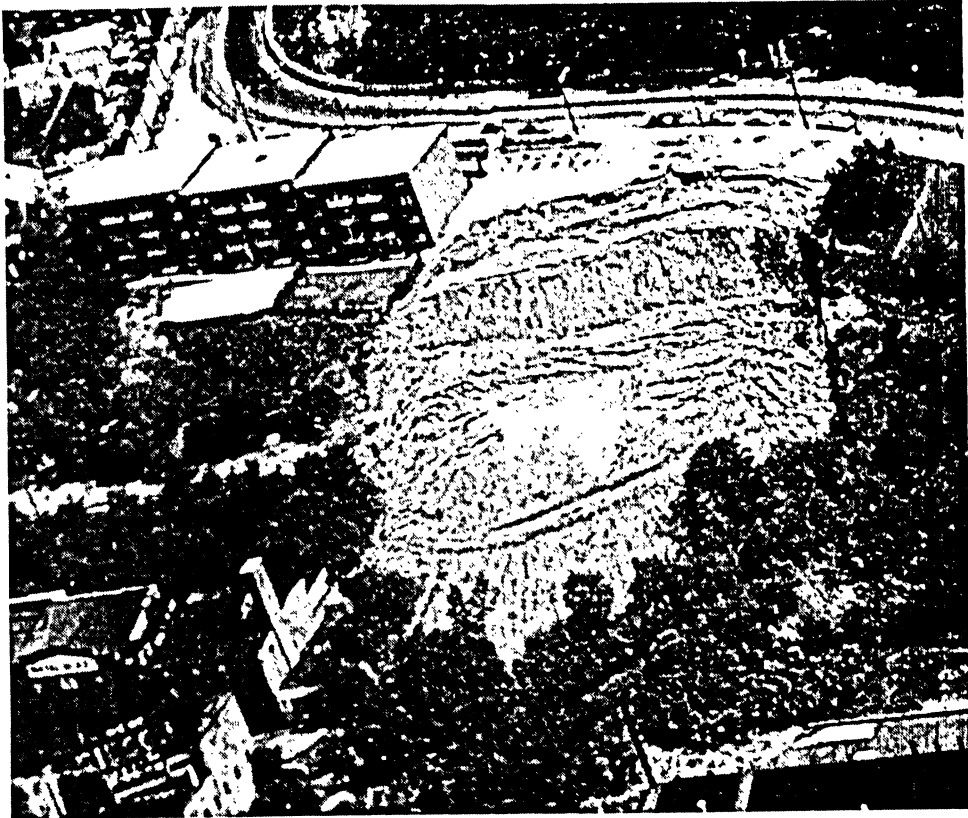
**Figure B.4** Large well developed landslide slump below the lower bend in Clifton Avenue. The landslide occurred in 1966 and involved litigation. Varnes (1978) block diagram illustrates landslide features. Photo courtesy of the City of Cincinnati.

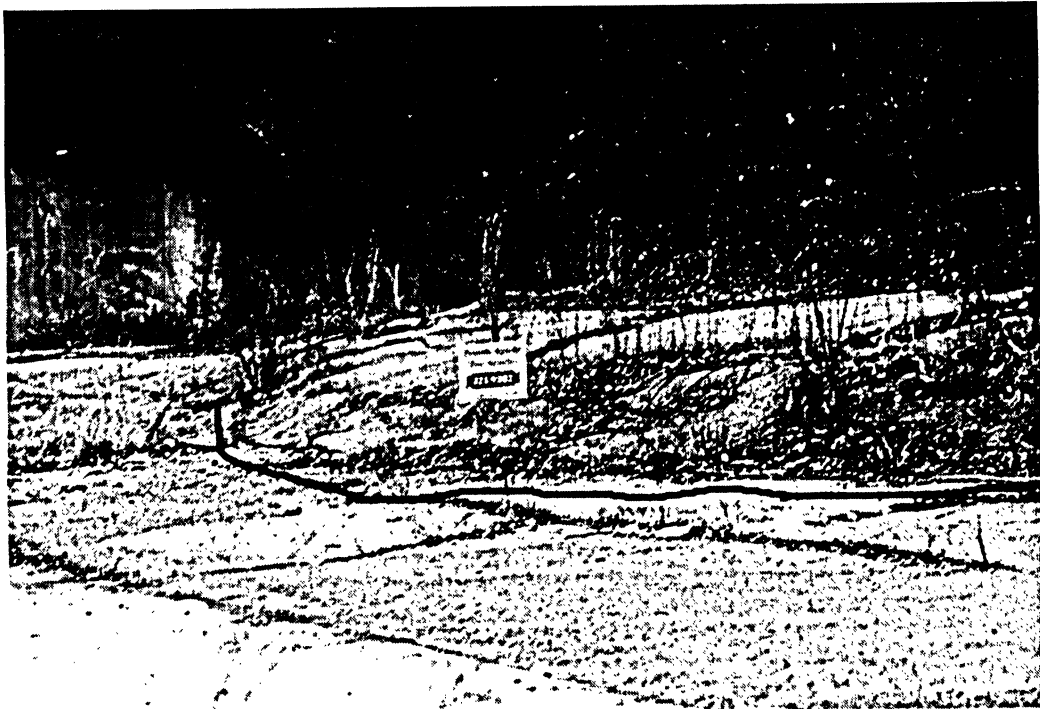
**Figure D.4** Landslide toe located off of River Road in asphalt parking lot. Illustrates subtle nature of uplifted toe area, readily apparent because it crosses man-made feature. Real estate sign is eighteen inches high.

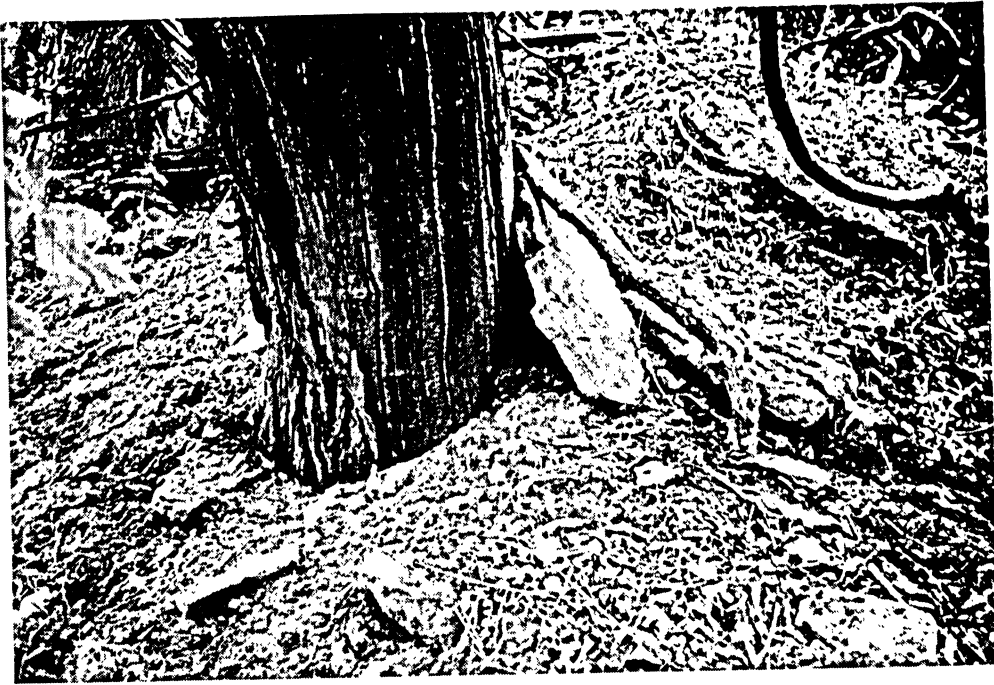
**Figure D.5** Tree being buried by deep slump above Maryland Avenue at the south end of Goforth Street.

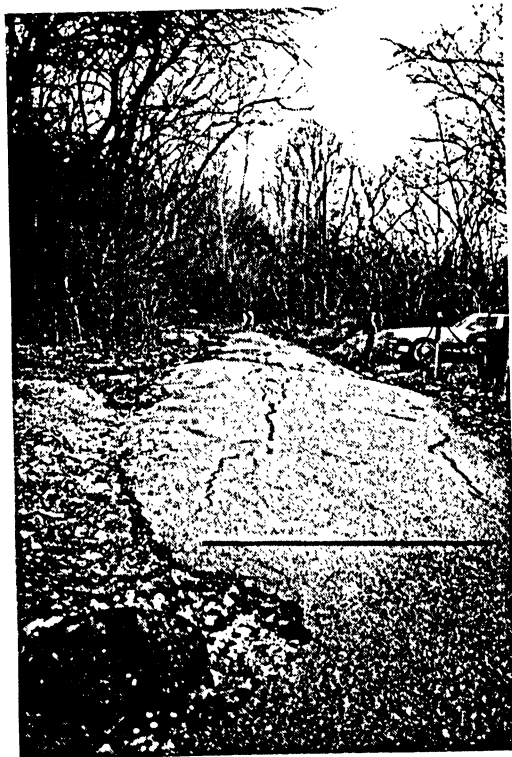
**Figure D.6** Asphalt pavement uplifted past the horizontal line at the northern end of Bowman Street. Tension cracks run parallel to axis of street.

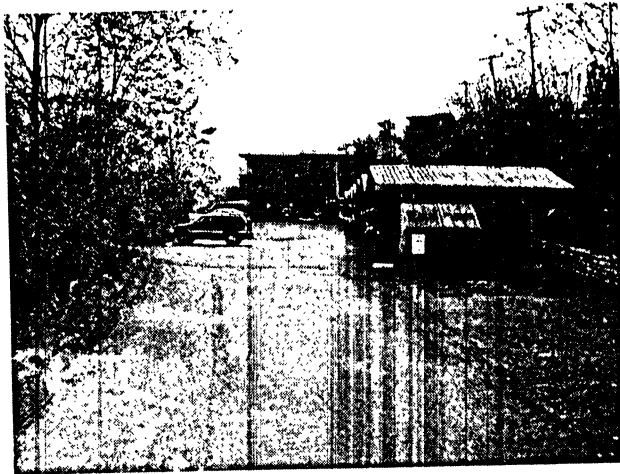
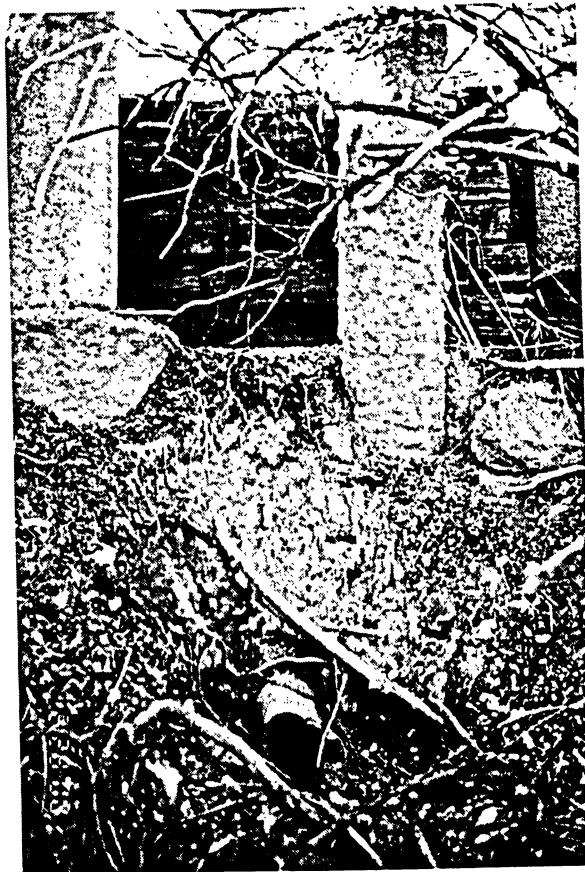
**Figure D.12** Failure in front of pier wall. Note concrete pipe (lower photo) that drains the entire parking lot (upper photo) onto the hillside.

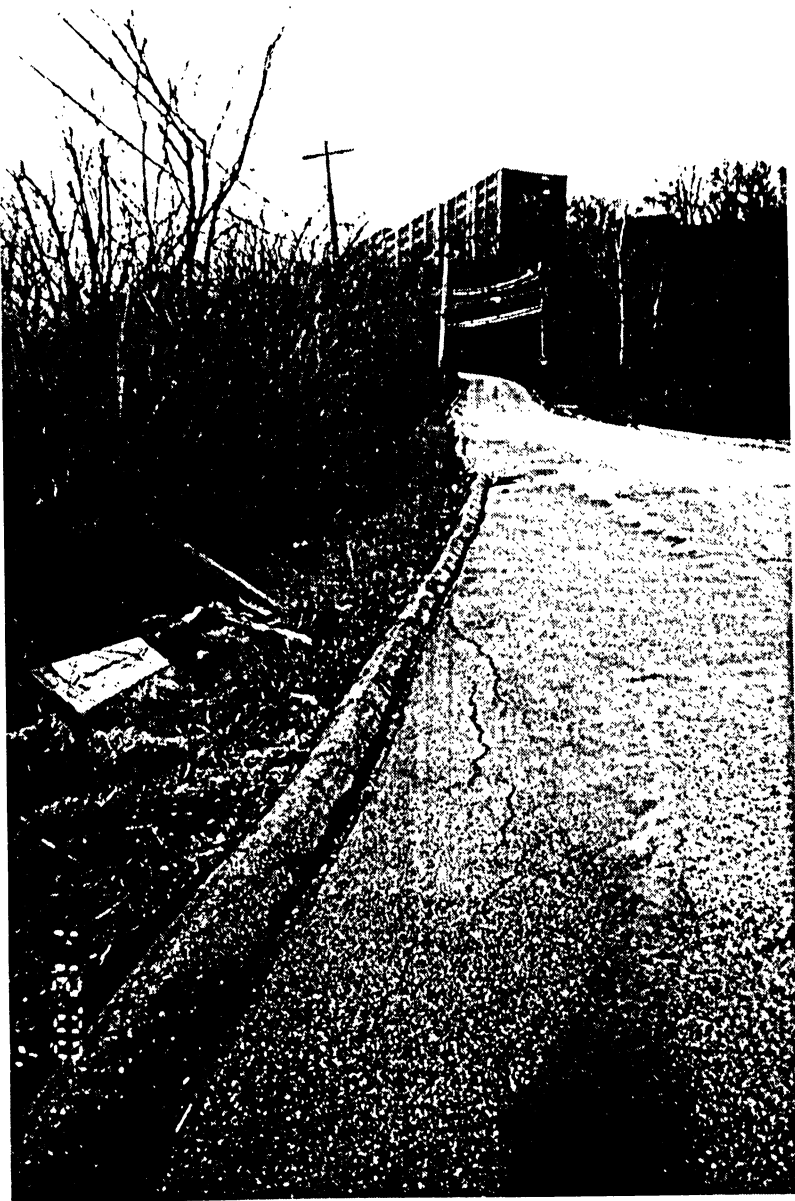
**Figure D.13** Lehman Avenue asphalt patching on the down hill side of the road. Note new tension cracks already forming. Water sheets over the down hill curb in the upper portion of the road.

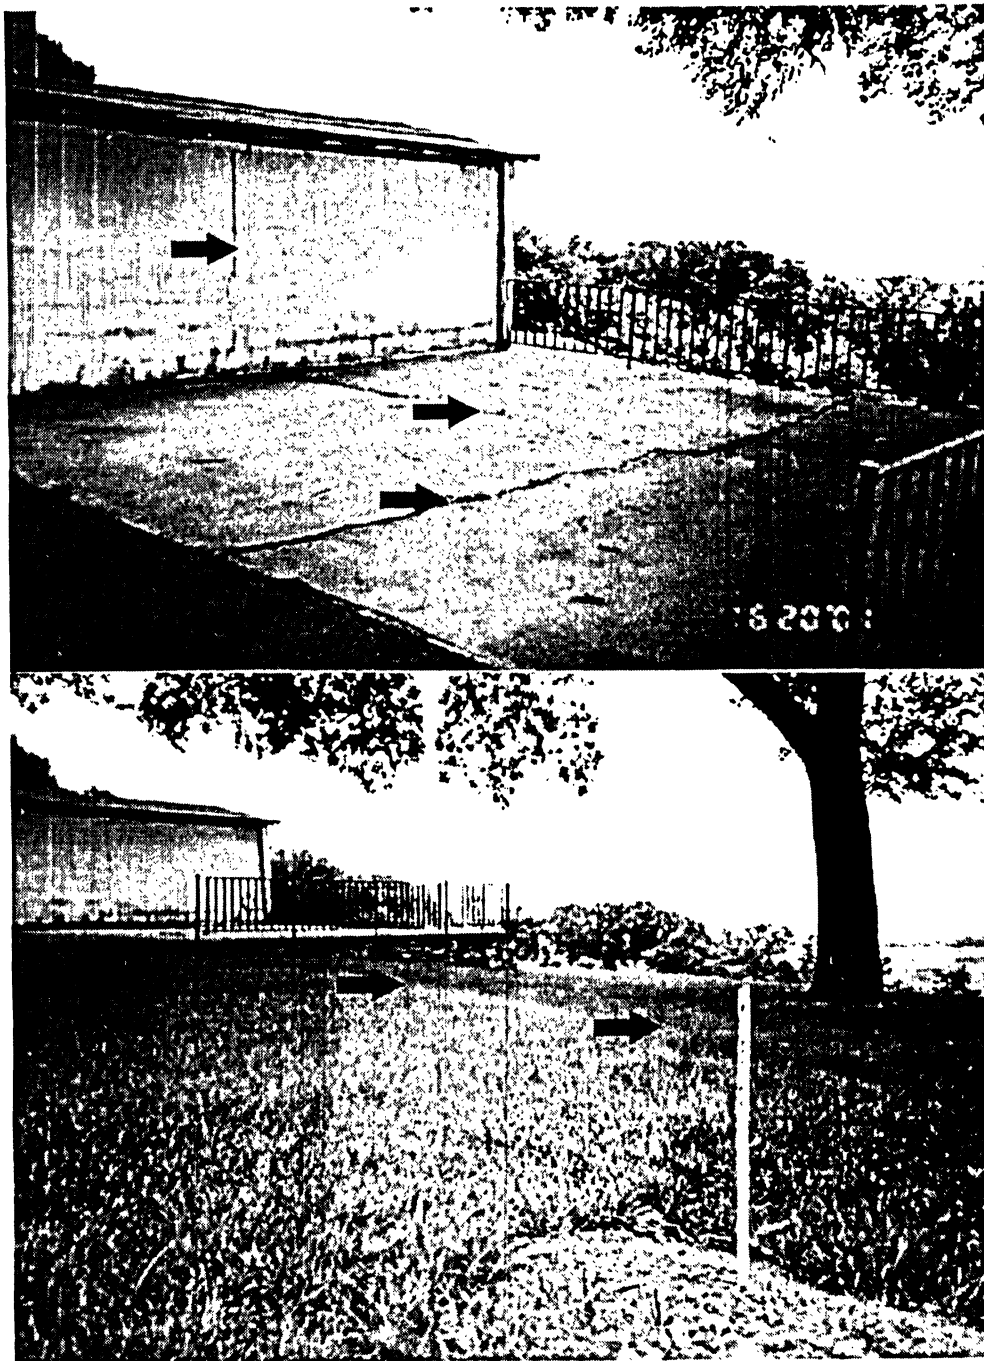
**Figure D.14** Subtle vertical offset in topography lines up with cracked parking pad and cracked cinder block wall. Feature also follows the general trend of the crest of the hillslope to the north of site. Photograph is looking north-east into the Mill Creek Valley.

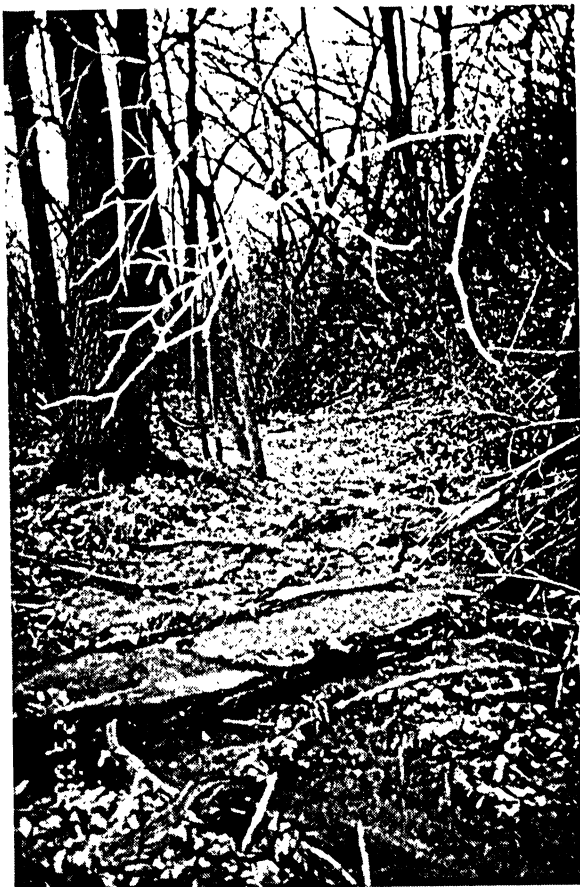
**Figure D.15** Sag pond located on landslide below Lehman Avenue. Silt and clay indicate ponding of surface water.

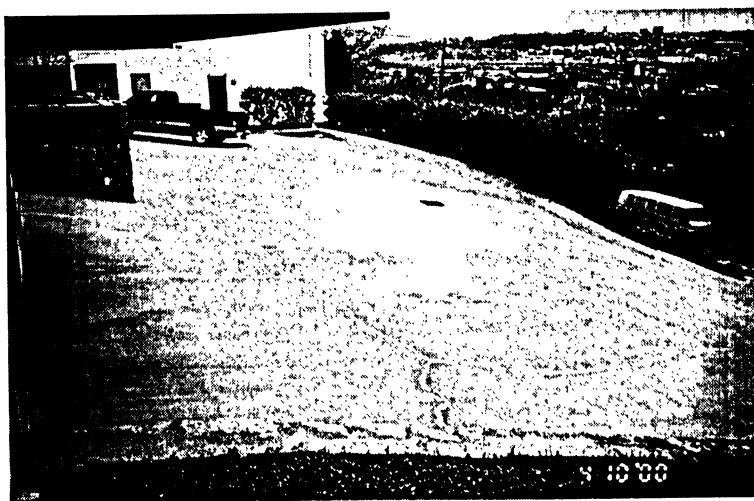
immediately behind the house at 2325 Maryland Avenue the slope is bulging and pine trees planted exhibit curving trunks (Figure D.10)). Additionally, the condominium project concrete parking pad (Figure D.16) and driveway located in front of the project exhibits tension cracks that at this time can be attributed to differential settlement and/or creep of fill placed downhill of the excavated site. There appears to be no retaining structure supporting this embankment fill.

**Figure D.16** Tension cracks in unbuttressed embankment fill due to creep and/or settlement.

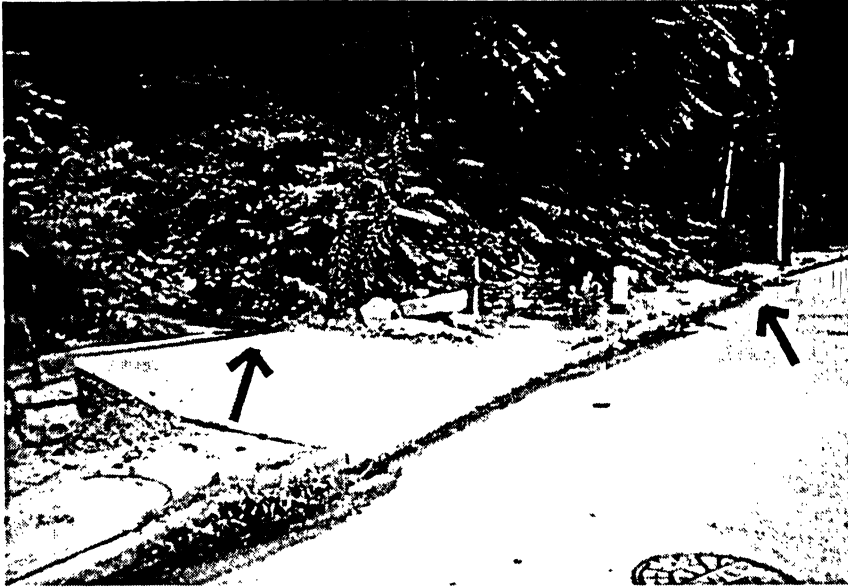
exits below the outer curve of the roadway. A seep (Figure D.17) that flows year round and has been flowing at least since 1937 (verbal communication with local resident) is located just below the bend in Maryland Avenue. Directly below this, on Wilder Avenue and in line with the buried (by humans) drainage are large gravity walls that show seepage at the foot of the wall and effervescence staining due to seepage. The deep landslide roughly encompasses the area of Wilder Avenue, extending to the west to Warsaw Avenue and probably past Glenway Avenue to the east. This landslide is probably associated with the cut and fill work for Wilder Avenue and the extensive excavation made below on Glenway Avenue (Figure F.7 & F.8) in the early 1900's.

**Figure D.17** Seepage (arrows) flows year round at this location below the bend in Maryland Avenue on Warsaw Avenue. This seep was used in 1937 during the flood for drinking water; domestic well pit is located up slope.

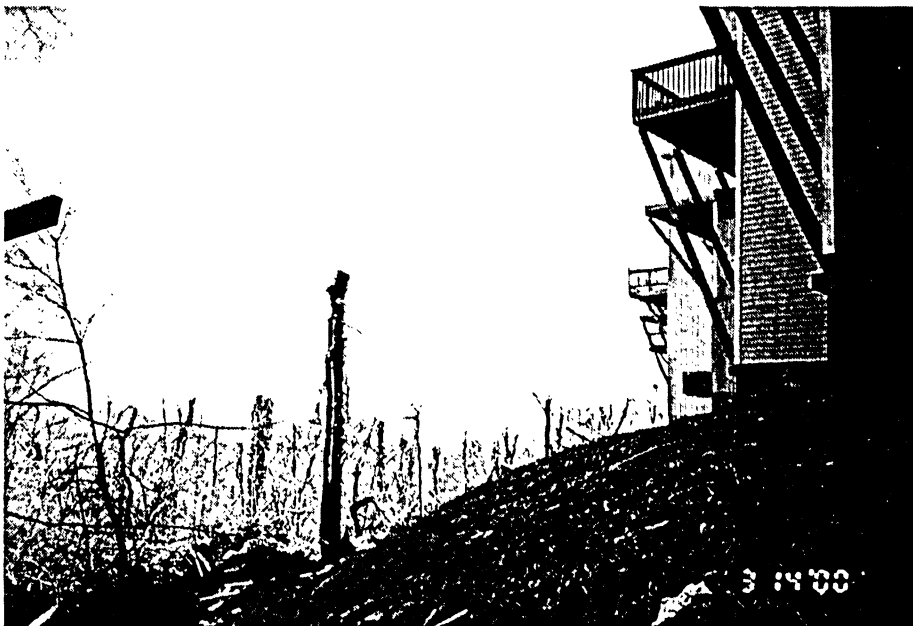
**Figure D.22** Clear cutting and topping of trees for the view. Note that deck supports are braced against the foundation.

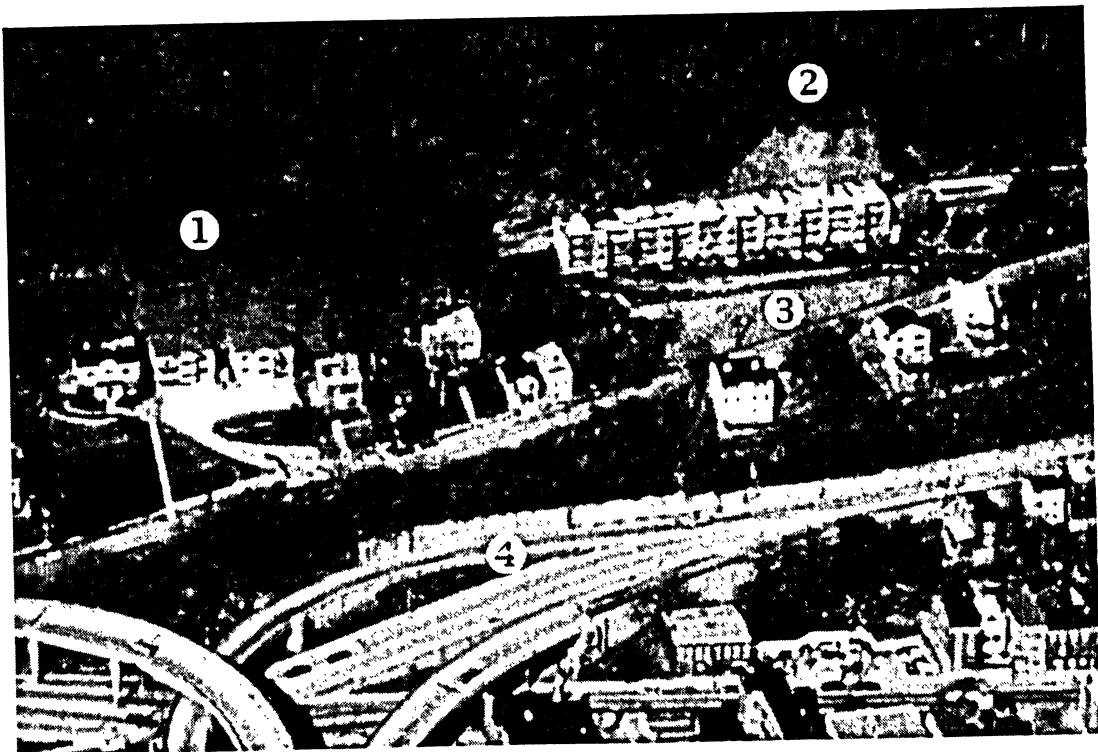
**Figure F.3** Oblique aerial photograph taken in 1992. Area 1 is the location of a landslide that occurred in 1982. Below area 2 is a landslide slump that came to within one foot of the apartment building. Area 3 exhibits slump characteristics today. Area 4 is the Warsaw-Waldvogel Viaduct wall panels. Courtesy of City of Cincinnati.

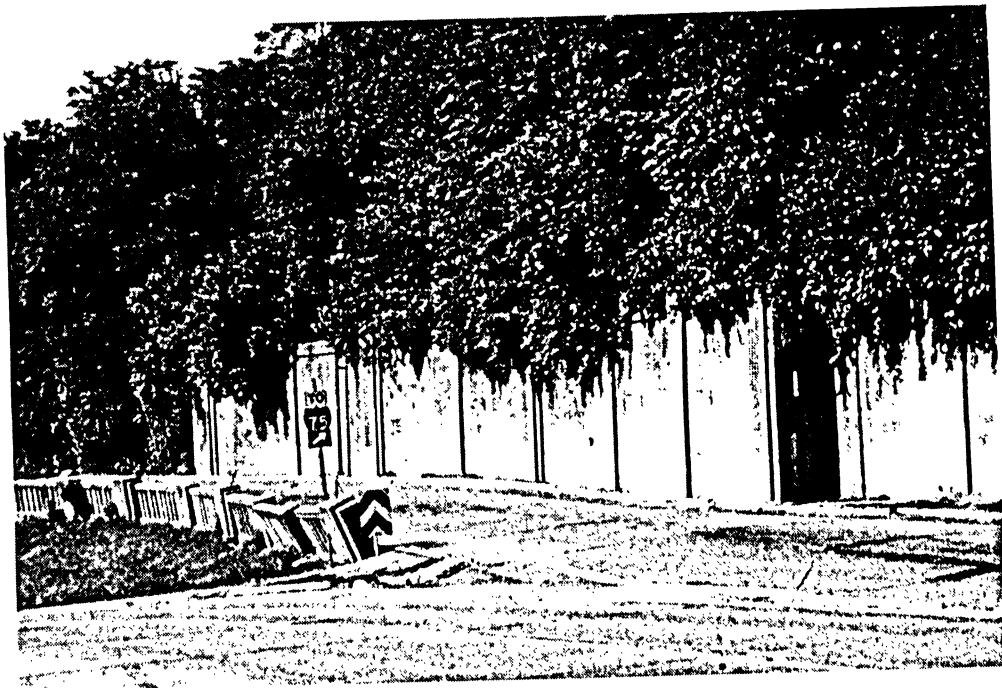
**Figure F.5** Warsaw-Waldvogel Viaduct. Picture taken in 1990. Note the concrete railing is tilted out due to ground movement. Compare to Figure F.4. Photograph courtesy of the City of Cincinnati.

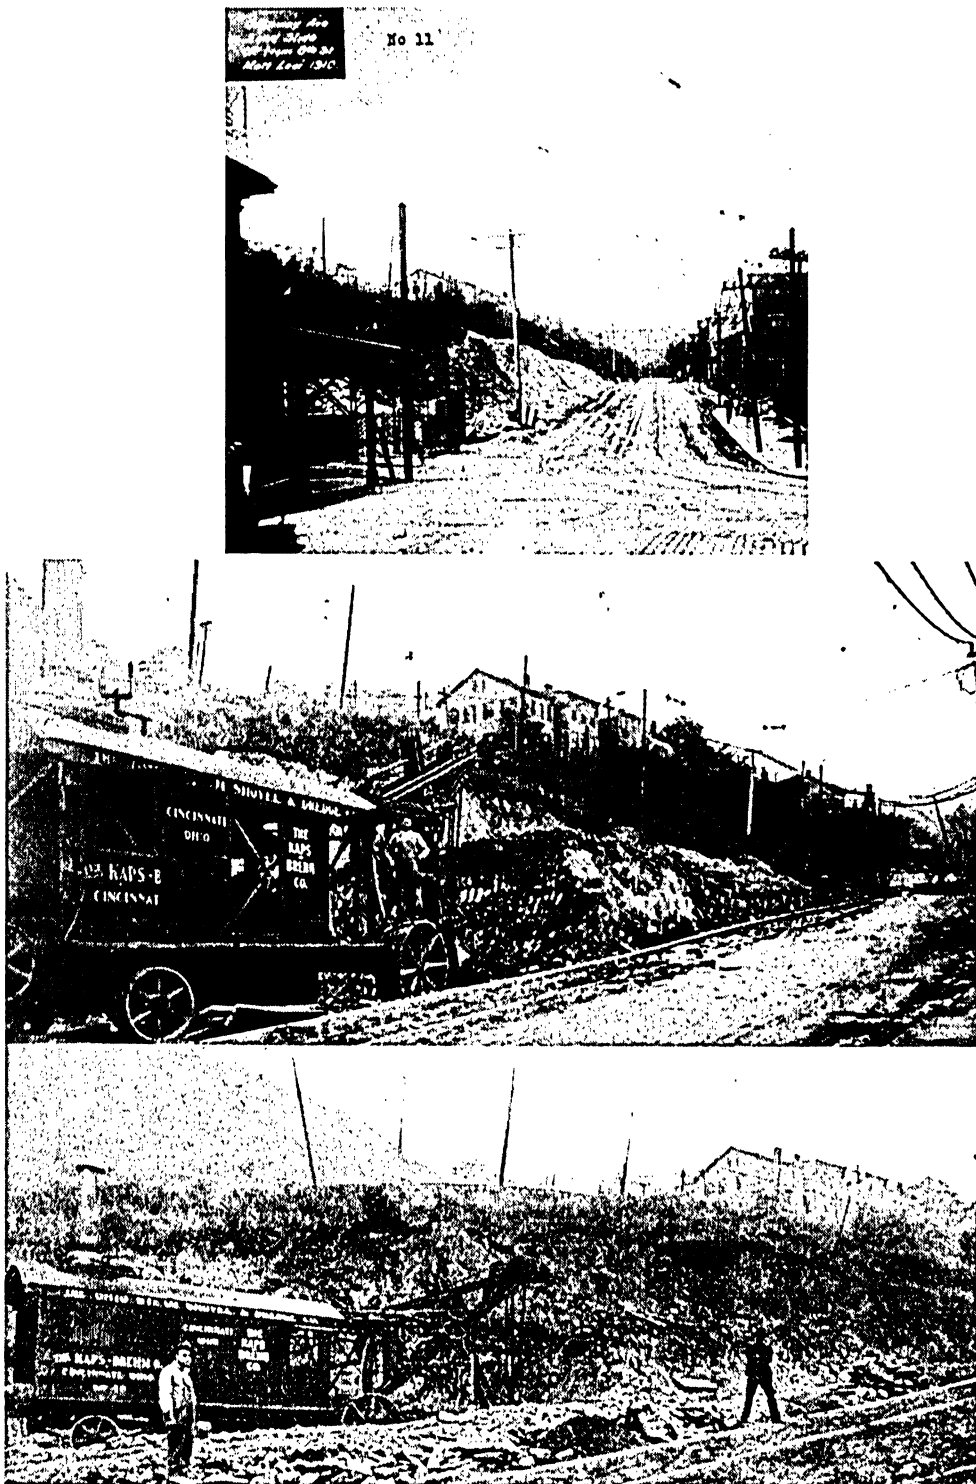
**Figure F.7** Upper photograph (1910) shows toe of landslide on Glenway Avenue just north of the Incline. Lower two photographs (early 1900's) show the widening of Glenway Avenue and the toe of the hillslope and/or the landslide mass being excavated below the bend in Wilder Avenue. From the Cincinnati Historical Society collection.

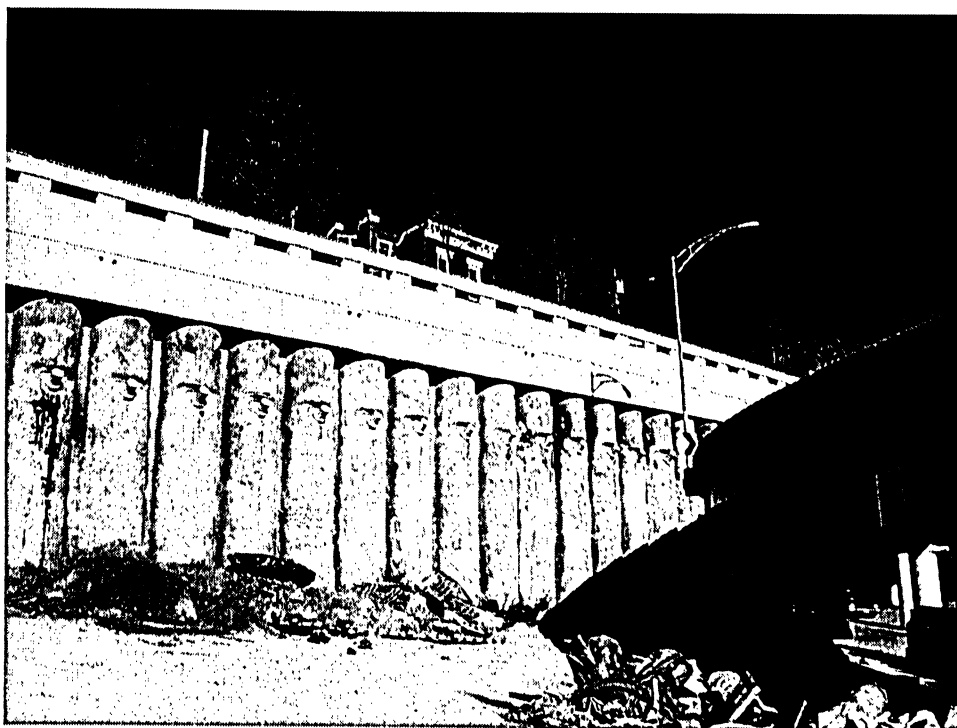
**Figure F.24** Mt. Adams pier wall. At one time this was one of the costliest landslides in the United States. On the right of the photo is I-471, the reason the toe of the hillslope was excavated.
