## **Heel Cup Redesign**

**Submitted in partial fulfillment of the degree of Bachelor of Science in  
CompE, EE, or EET as well as ME**

The goal of this project was to create a redesigned Heel Cup tooling head aiming to eliminate excess clamshell wasted during Multi-Color Corporation production runs. The Heel Cup is a 3-D printed tooling that allows clamshells (cardboard-like material molded into the shape of a closable clamshell) to be mounted in a fixed position in order to be correctly and consistently labeled in the same place repeatedly (for all clamshells).

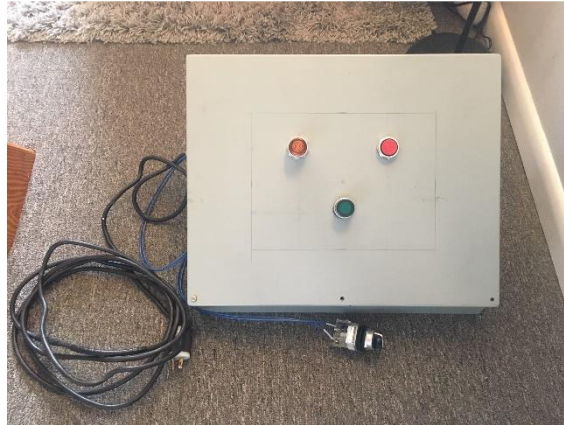
**Figure 1: Enclosure Outside View**

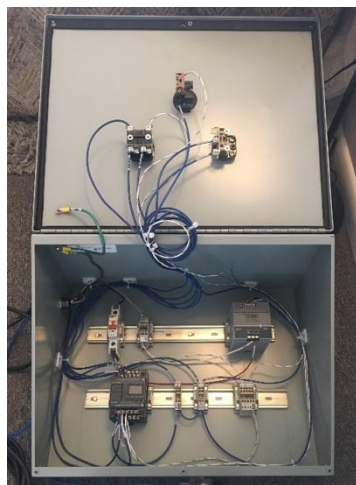
**Figure 2: Enclosure Inside View**

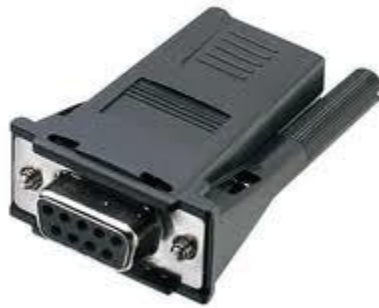
**Figure 22: OP-26486**

The RS-232 was used to connect a USB (Serial) port from a laptop to the OP-26486, which is used to connect to the PLC (6-pin head). A RS-232 cord is easy to acquire through online purchasing, but because the OP-26486 is sold through Keyence the price and estimated shipping time were not in the bounds of the project. The RS-232 was purchased for the project, but the OP-26486 was not able to be attained. Brent Rodgers supplied the OP-26486, but due to conflicting schedules, Brent Rodgers was only able to give the project access to the cord once a week every Friday, from approximately 9:00am to 12:00pm. This caused the program writing and troubleshooting process to be dramatically slowed, but because this issue could not be worked around (Rodgers work schedule wouldn't allow it), the time slot was used to its full potential every Friday in order to make significant progress on the project.
