*It is entitled* LAND USE AND LANDSLIDING IN  
PRICE HILL, CINCINNATI, OHIO

**LAND USE AND LANDSLIDING IN PRICE HILL,  
CINCINNATI, OHIO**

**TIM J. AGNELLO**

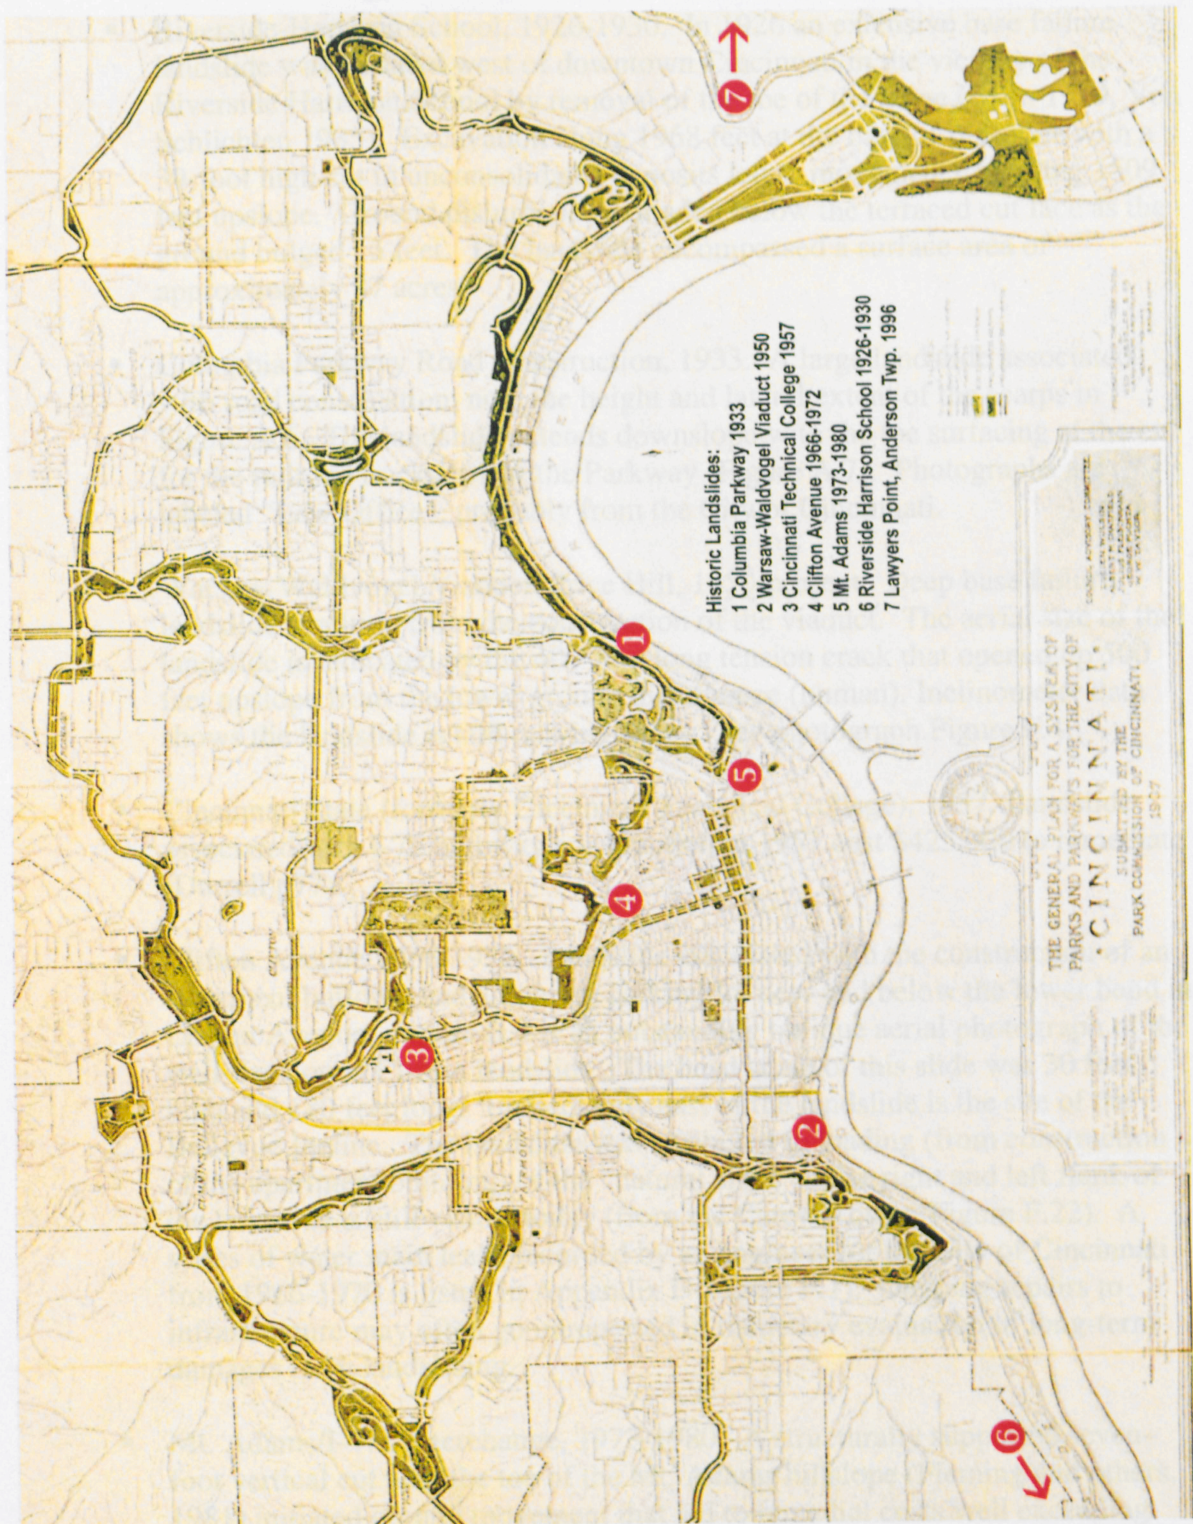
**Figure 2.7** Location map for historic landslides. Note that most of these large landslides were associated with construction projects that probably involved preconstruction engineering analysis. George Kessler map is courtesy of Cincinnati Historical Society.

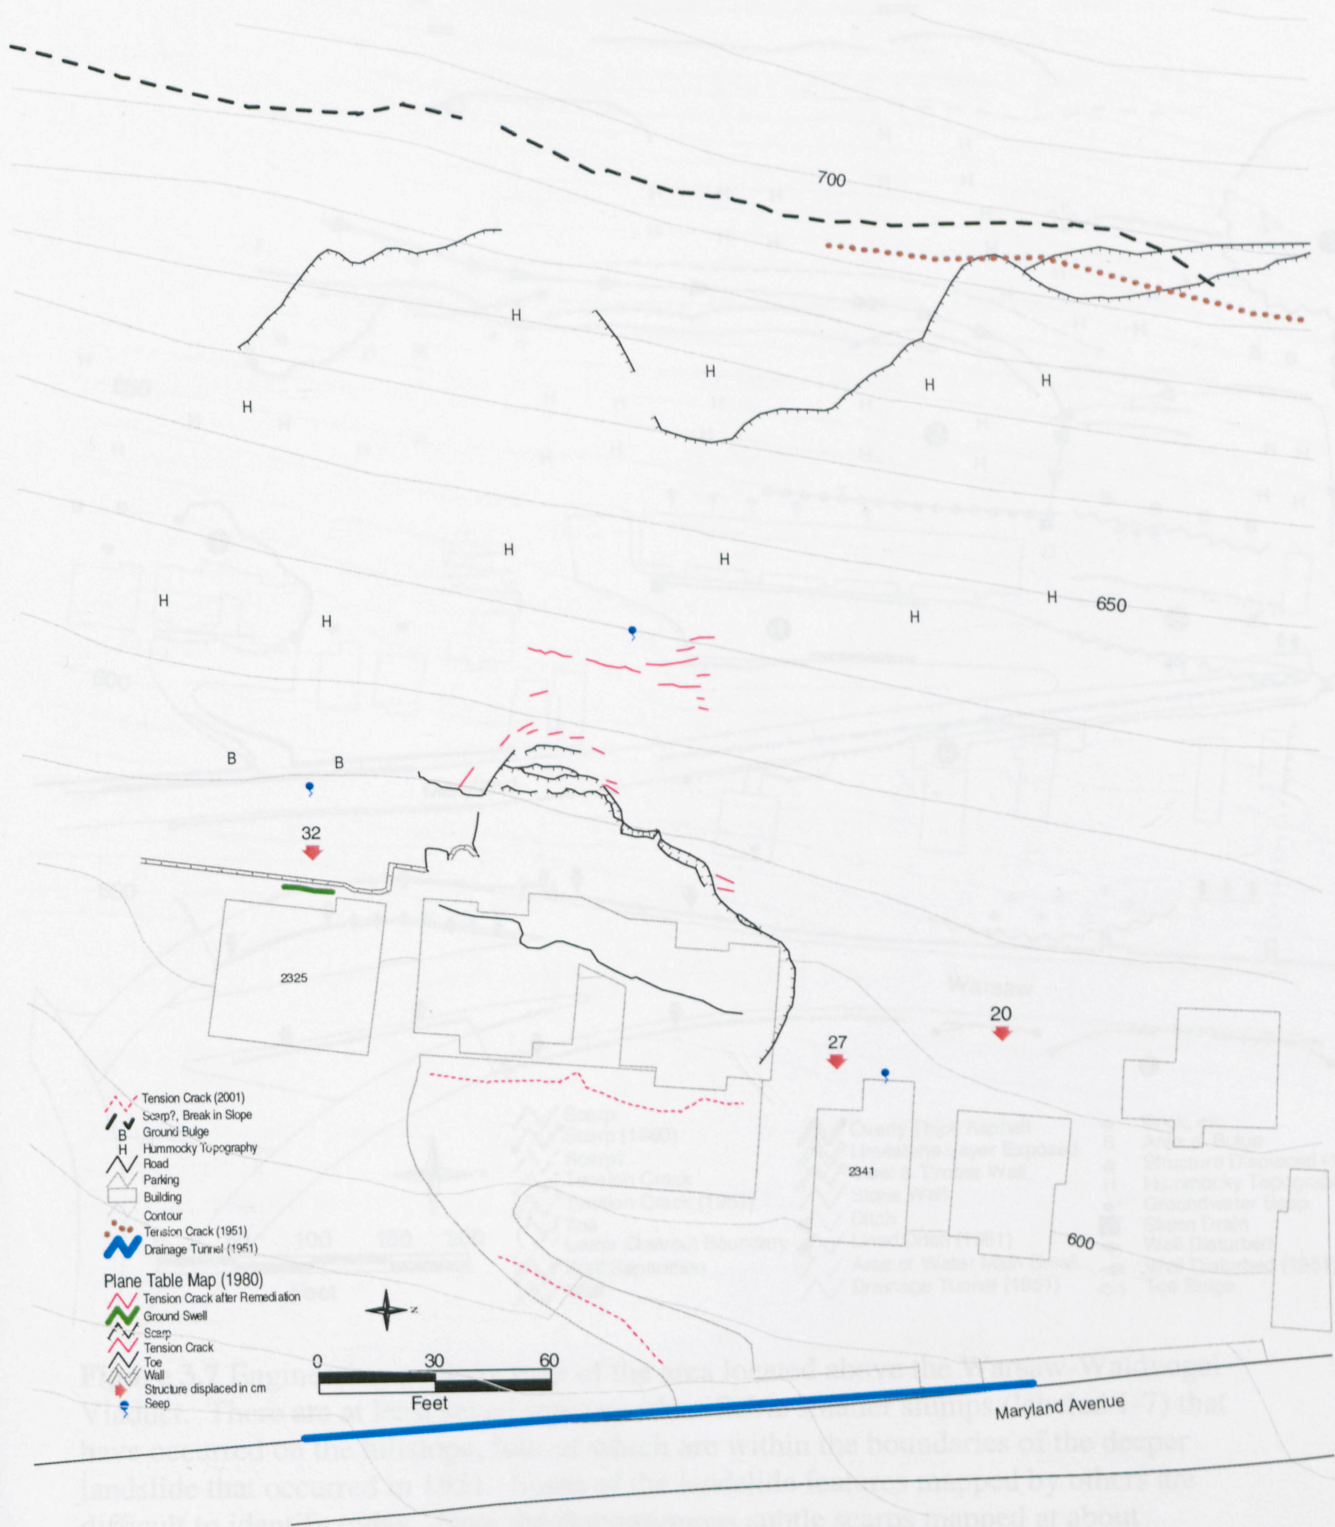
**Figure 3.6** Plane table map of landslide features above Maryland Avenue mapped by Aytuna and Brian, 1980.

A plane table map (Figure 3.6, Aytuna & Brian, 1980) shows the ground disturbance (toe) of the slide laterally doubled the width of the cut. The toe of the slide moved into the area of the cut and the associated uphill scarp mimicked the lateral extent of the downhill cut area. However, the ground was disturbed to either side of the cut showing displacement of structure located up to 66 feet north of the cut and 39 feet south of the cut.

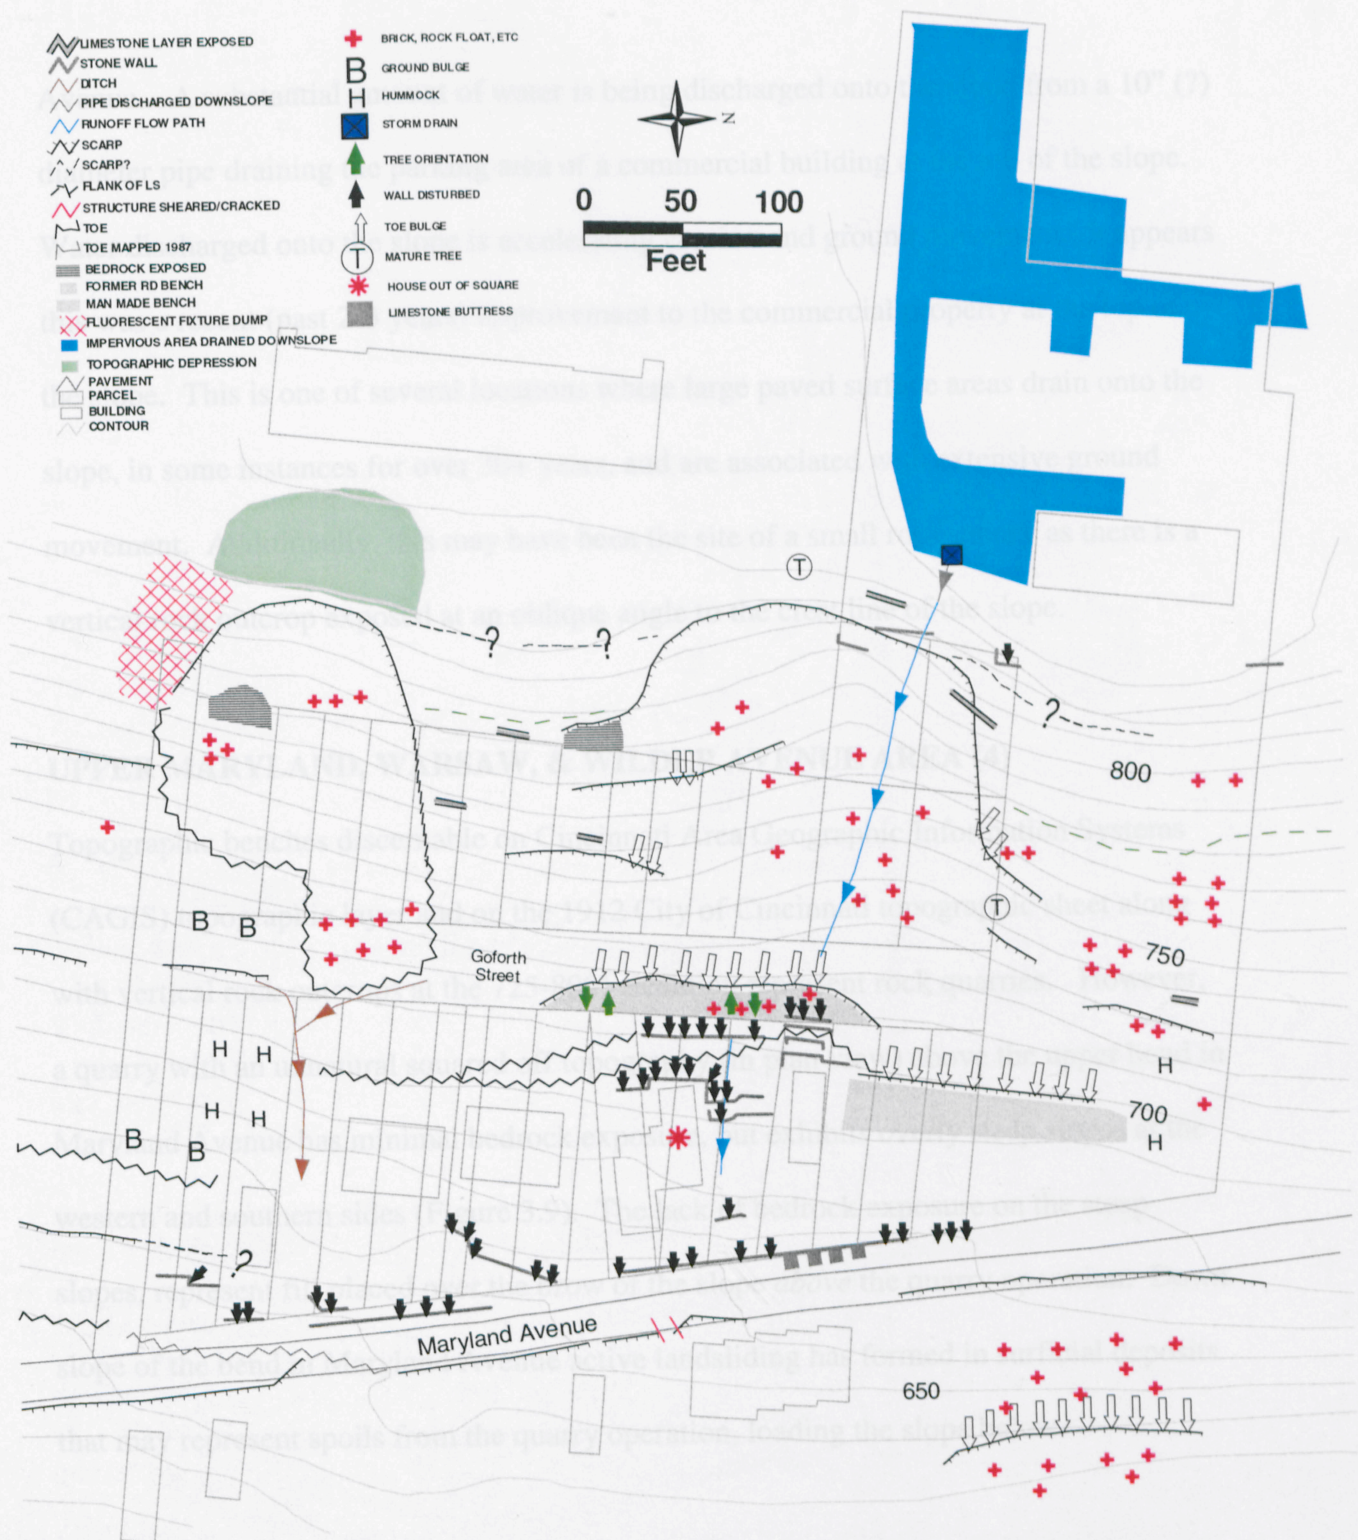
There is an extensive buttressed limestone wall (Figure F.10), supporting the housing terrace and Goforth Street that is bulging outward on the western side of Maryland

**Figure 3.8** Engineering geology map of Goforth Subdivision. Goforth Street and underutilized residential lots above Maryland Avenue. Note that the large commercial parking pad (shown in blue) culvert empties onto the hillslope. This is also the probable site of a small rock quarry in the scalloped northwest quadrant of the Goforth parcels. Additional evidence for the rock quarry includes a rock outcrop exposed at an oblique angle to the crest (trends north-south) of the hillslope.

Avenue. A substantial amount of water is being discharged onto the slope from a 10" (?) diameter pipe draining the parking area of a commercial building at the top of the slope. Water discharged onto the slope is accelerating erosion and ground movement. It appears this was a recent (past 2-3 years) improvement to the commercial property at the top of the slope. This is one of several locations where large paved surface areas drain onto the slope, in some instances for over 30+ years, and are associated with extensive ground movement. Additionally, this may have been the site of a small rock quarry as there is a vertical rock outcrop exposed at an oblique angle to the crest line of the slope.

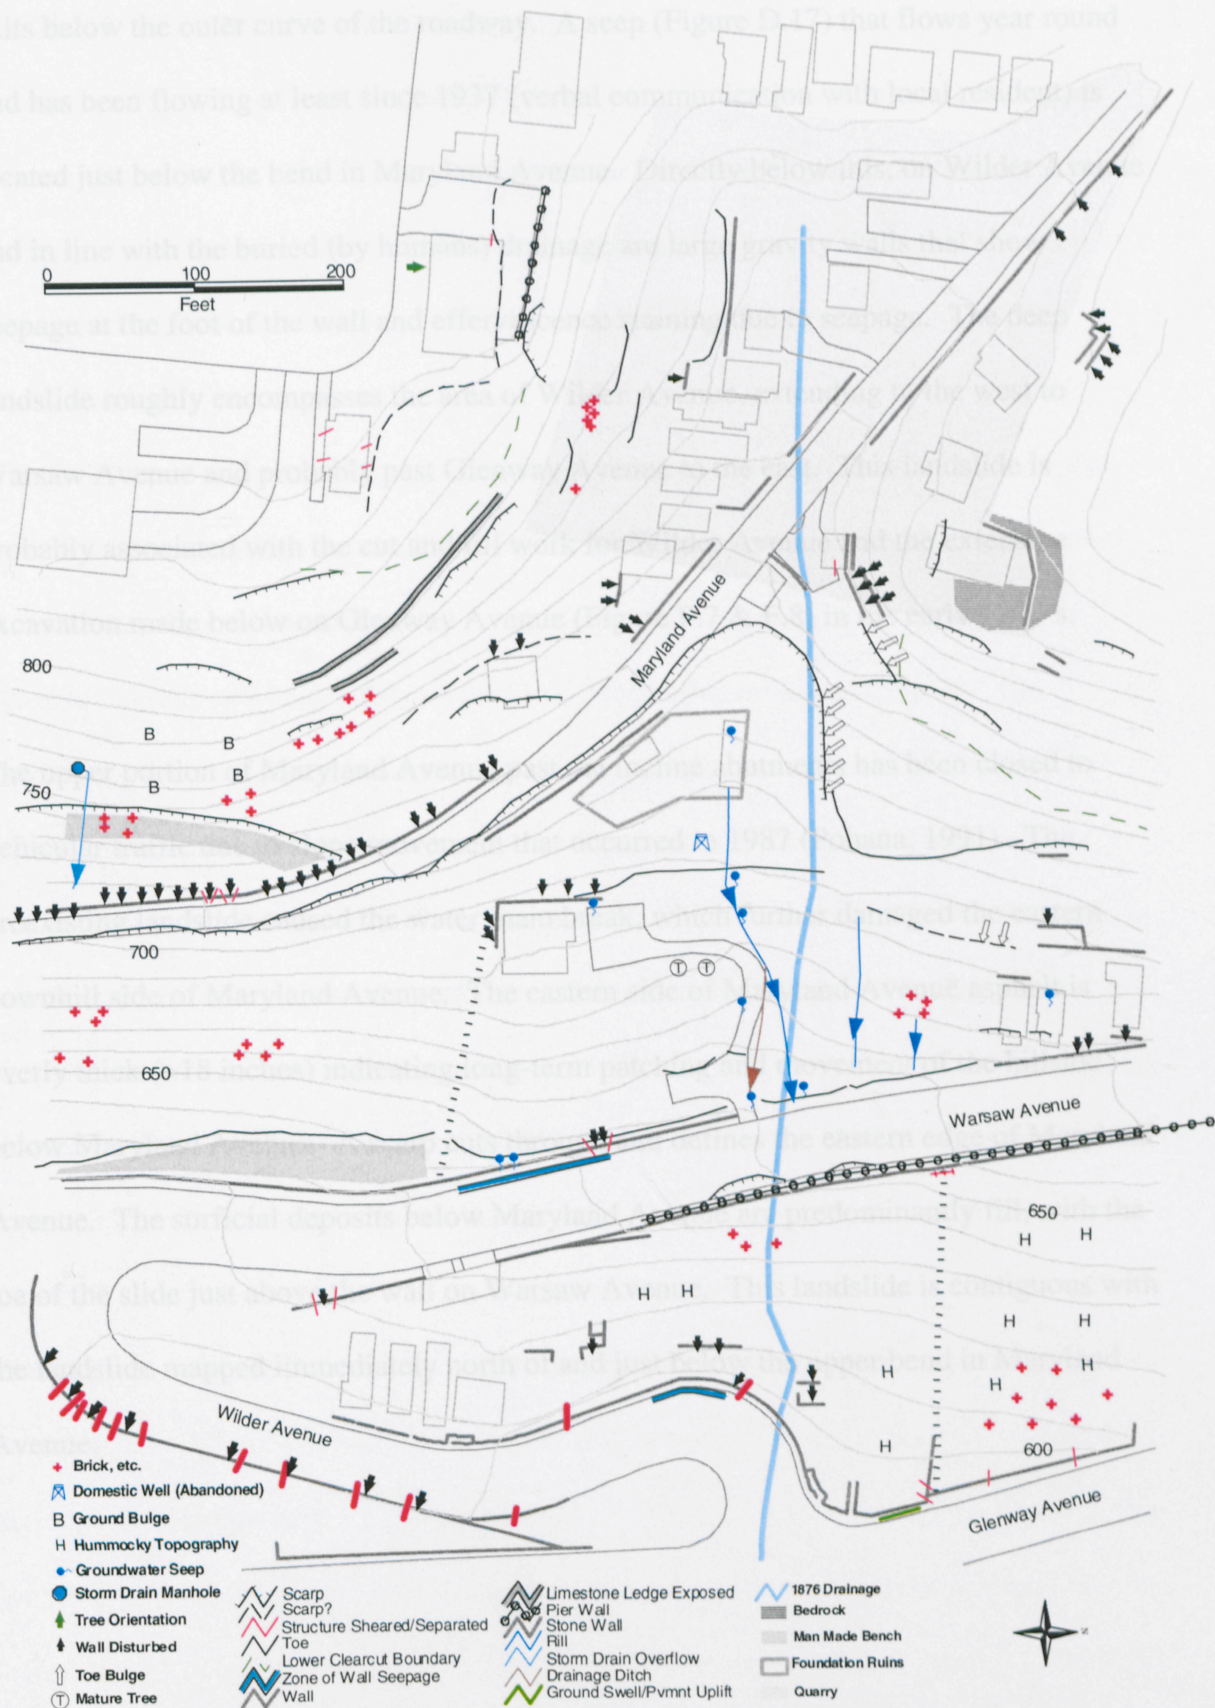
Figure 3.9 Engineering geology map of Maryland, Warsaw, & Wilder Avenue Area.

exits below the outer curve of the roadway. A seep (Figure D.17) that flows year round and has been flowing at least since 1937 (verbal communication with local resident) is located just below the bend in Maryland Avenue. Directly below this, on Wilder Avenue and in line with the buried (by humans) drainage are large gravity walls that show seepage at the foot of the wall and effervescence staining due to seepage. The deep landslide roughly encompasses the area of Wilder Avenue, extending to the west to Warsaw Avenue and probably past Glenway Avenue to the east. This landslide is probably associated with the cut and fill work for Wilder Avenue and the extensive excavation made below on Glenway Avenue (Figure F.7 & F.8) in the early 1900's.

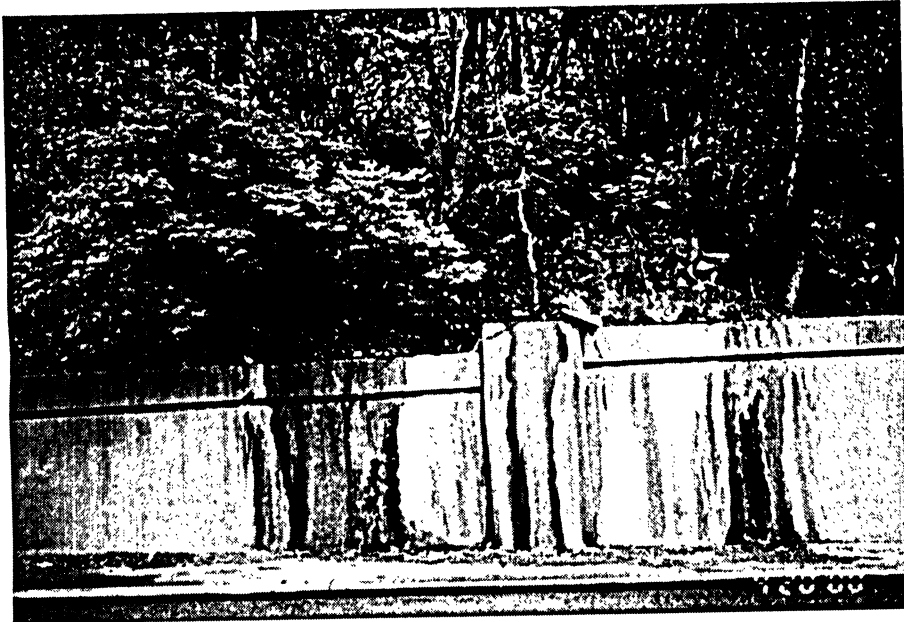
**Figure D.1** Landslide toe and seep on Elberon Avenue.

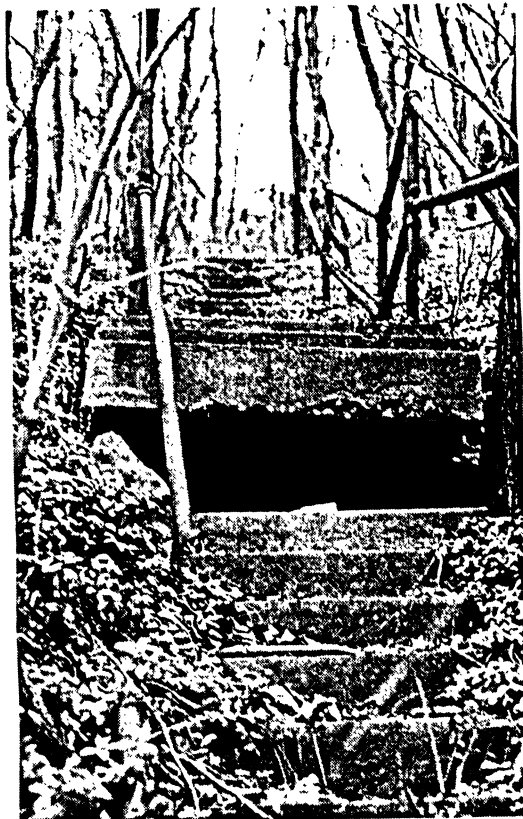
**Figure D.2** Steps displaced above Elberon Avenue.

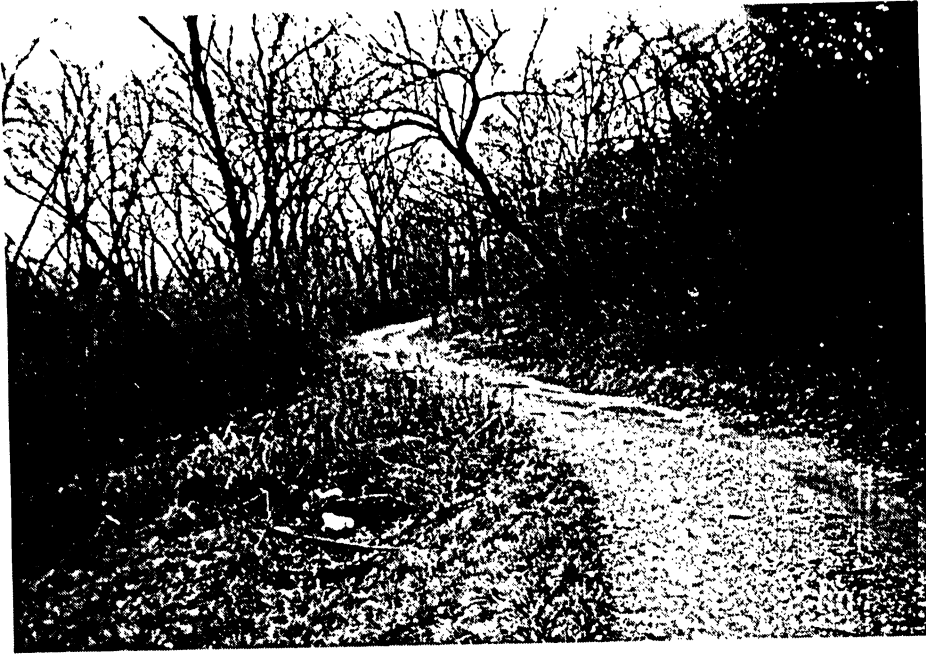
**Figure D.7** Shelby gravel road. Early documentation shows this road as being straight.

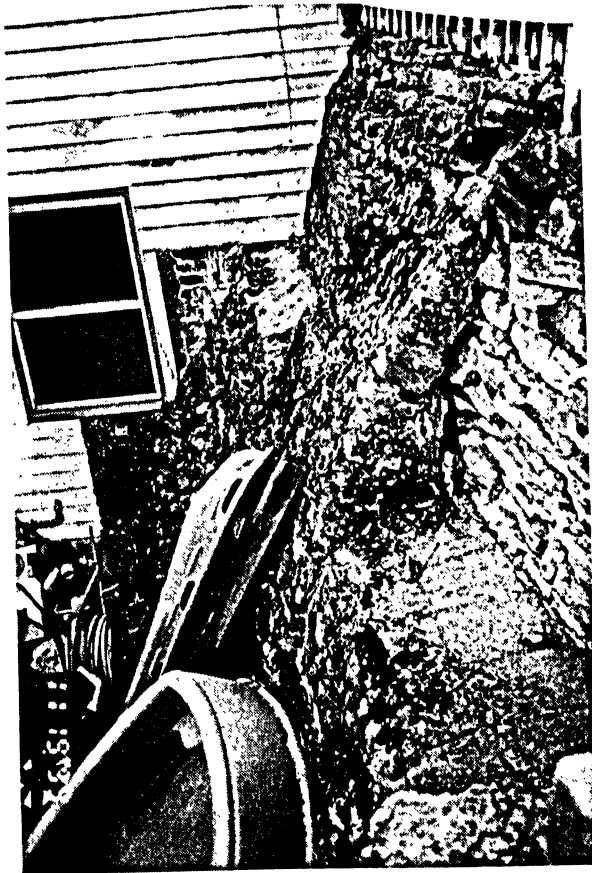
**Figure D.8** Neff Street. Wall bulges into house.

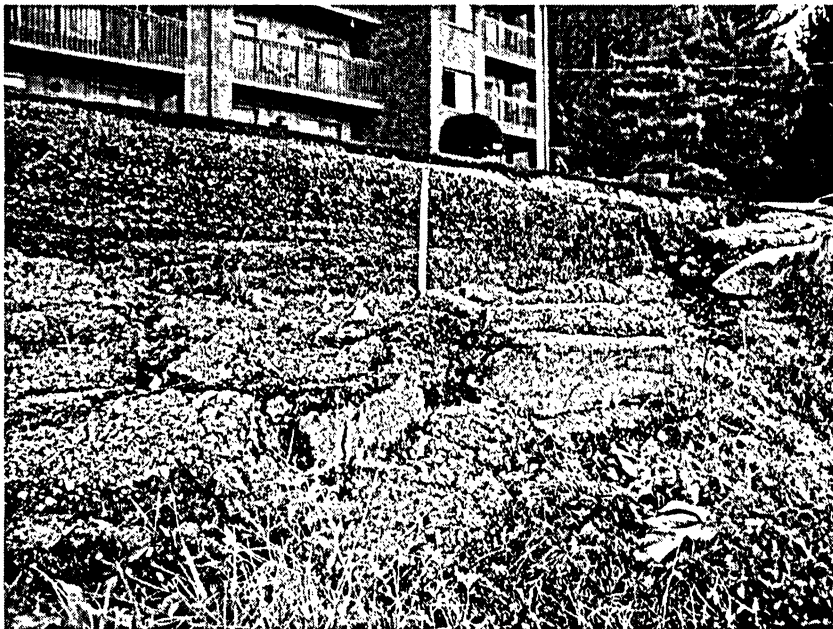
**Figure D.11** Maryland Avenue apartment complex asphalt parking pad. Vertical tape is extended out one foot for scale.

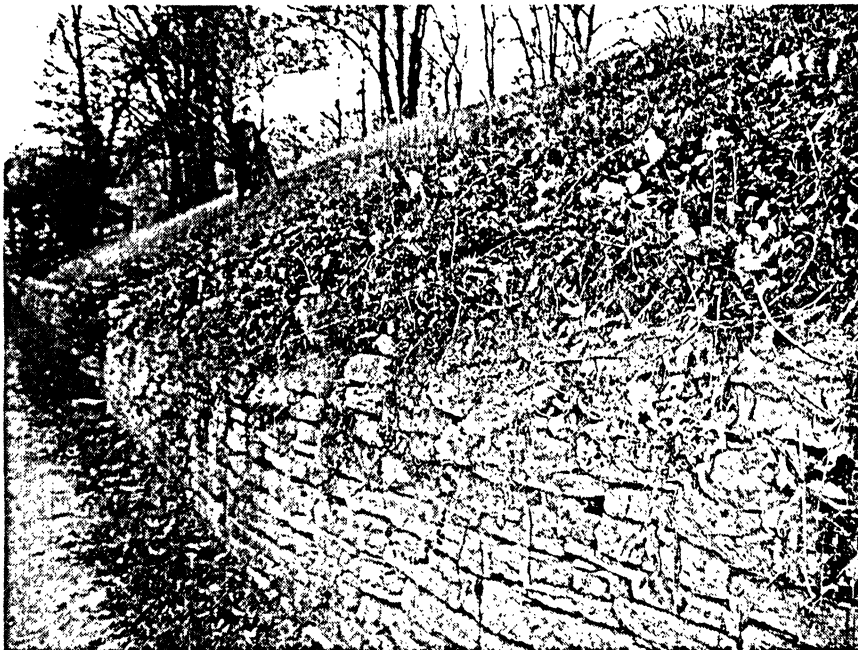
**Figure D.18** One of the few sites where creep can be accurately identified. Upper portion of wall is pushed out, area located below the Cincinnati Bible College on Glenway Avenue.

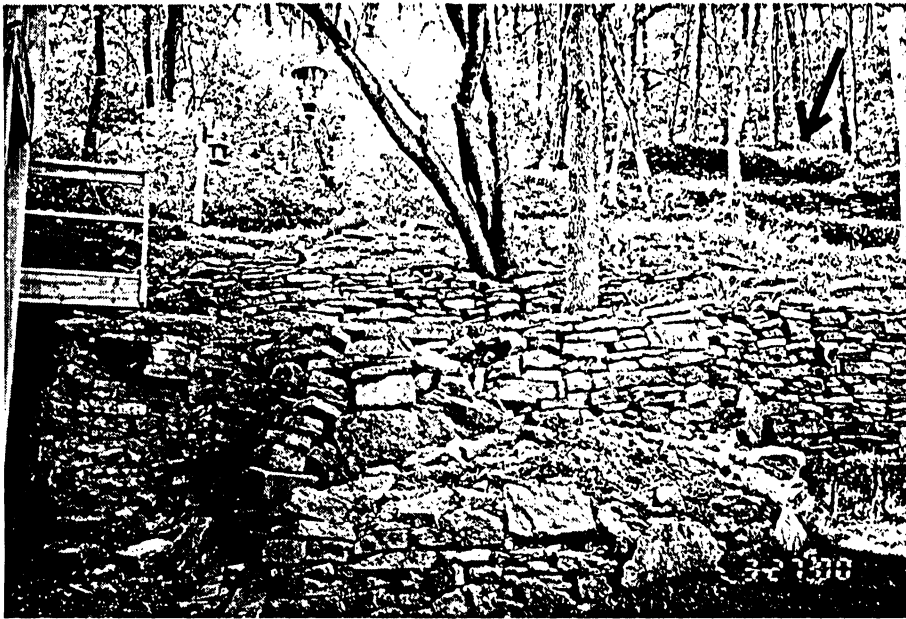
**Figure D.21** Series of limestone walls just above Maryland Avenue. Goforth Avenue terrace (arrow) as seen looking west from Maryland Avenue.

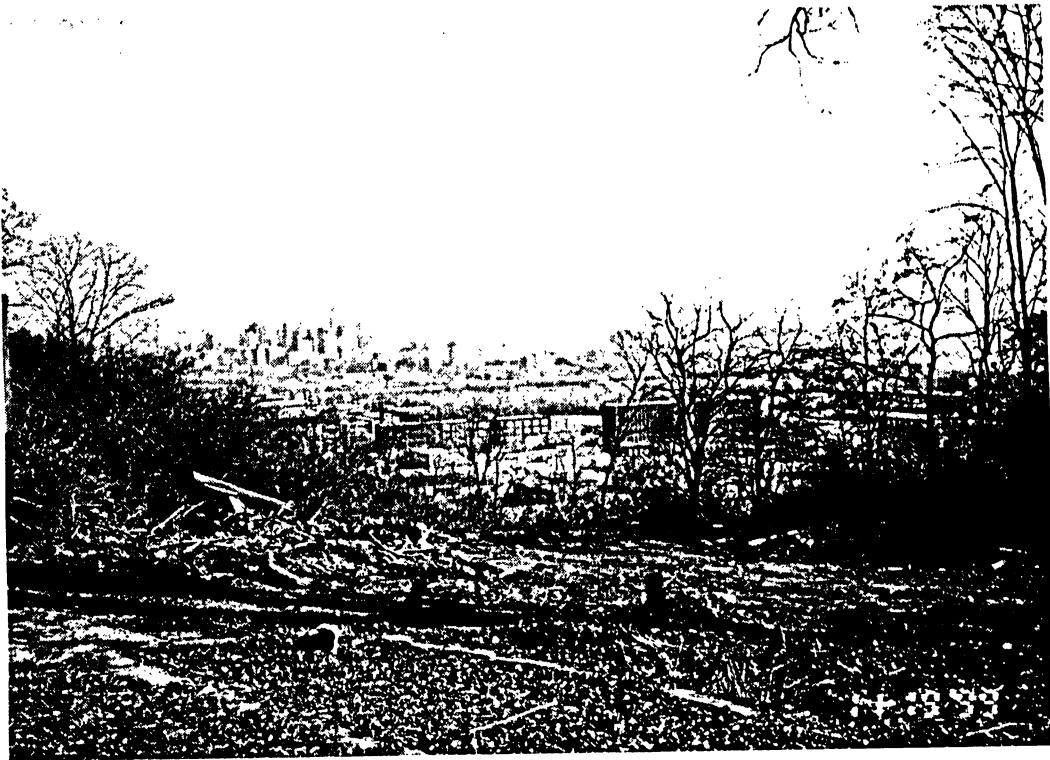
**Figure D.23** Spectacular view of downtown Cincinnati after clear cutting.

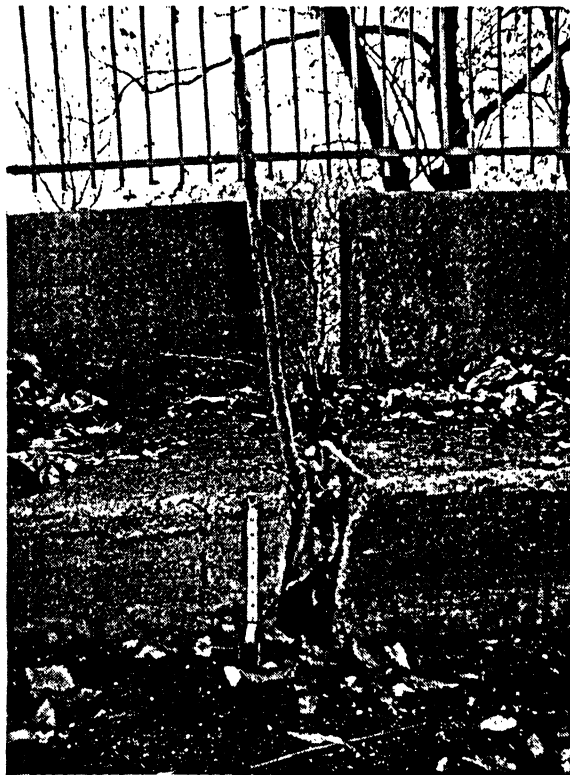
**Figure D.26** Separation of curb/upper wall on Wilder Avenue. Tape measure is extended one foot and shows drop in pavement.

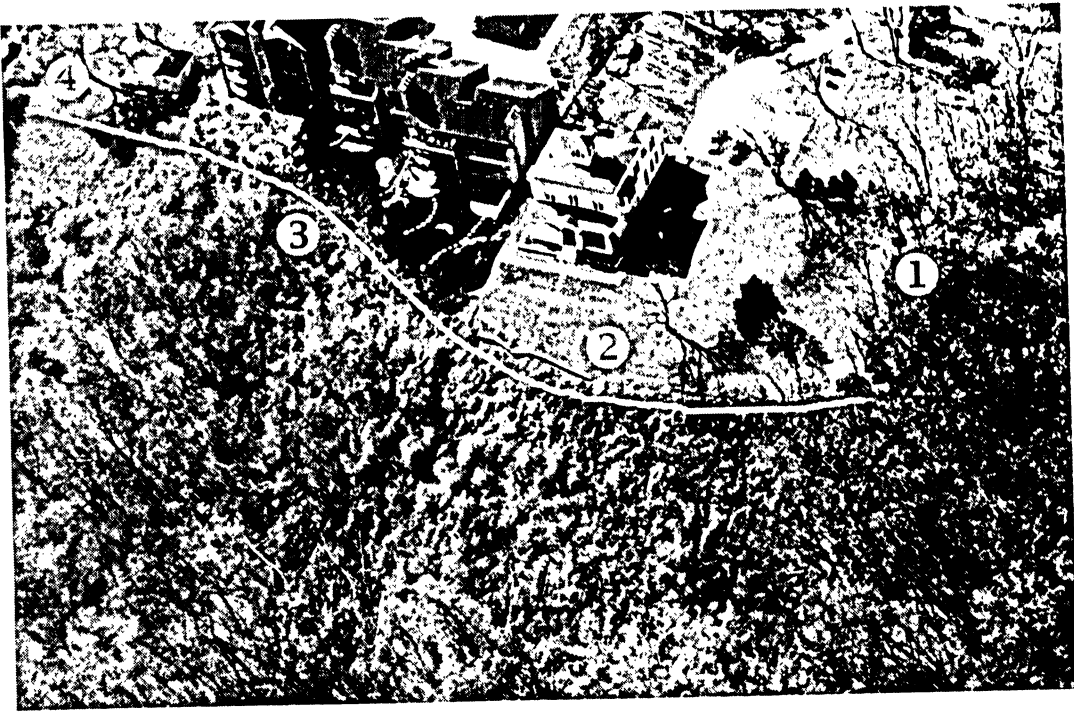
**Figure F.2** Oblique aerial photograph. Area 1 is the northern end of the Goodhue Rock Quarry. The white line follows the crest of the hillslope. Note in area 2 the crest of the hillslope is concave in and in area 3 concave out. Below area 3 is a large landslide slump. Area 4 is the location of the photographs from Figure D.14.

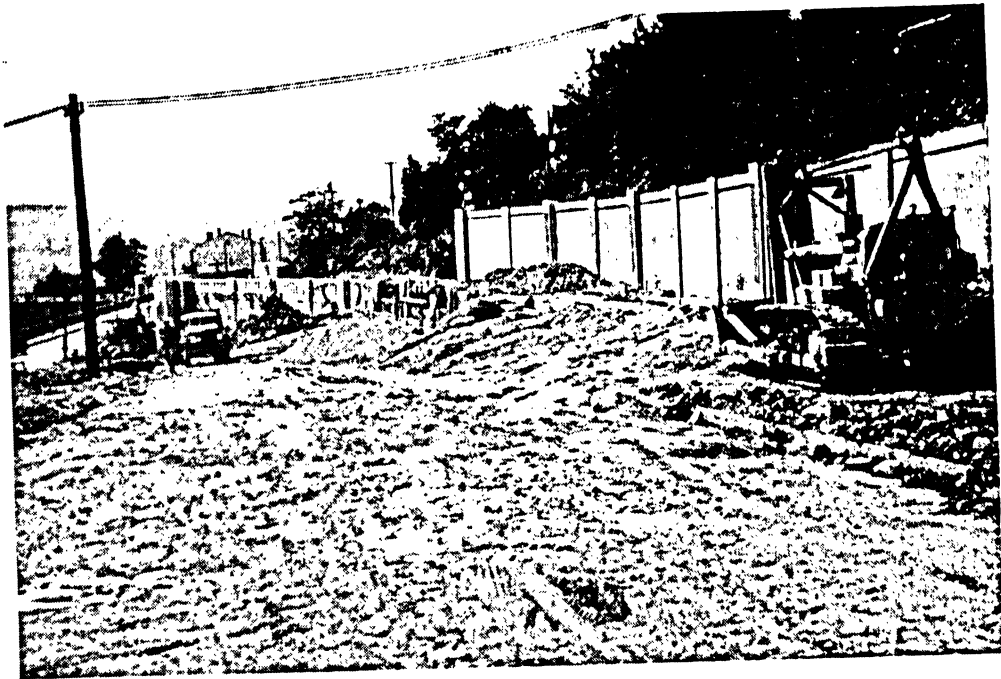
**Figure F.4** Construction of the Warsaw-Waldvogel Viaduct in 1950.

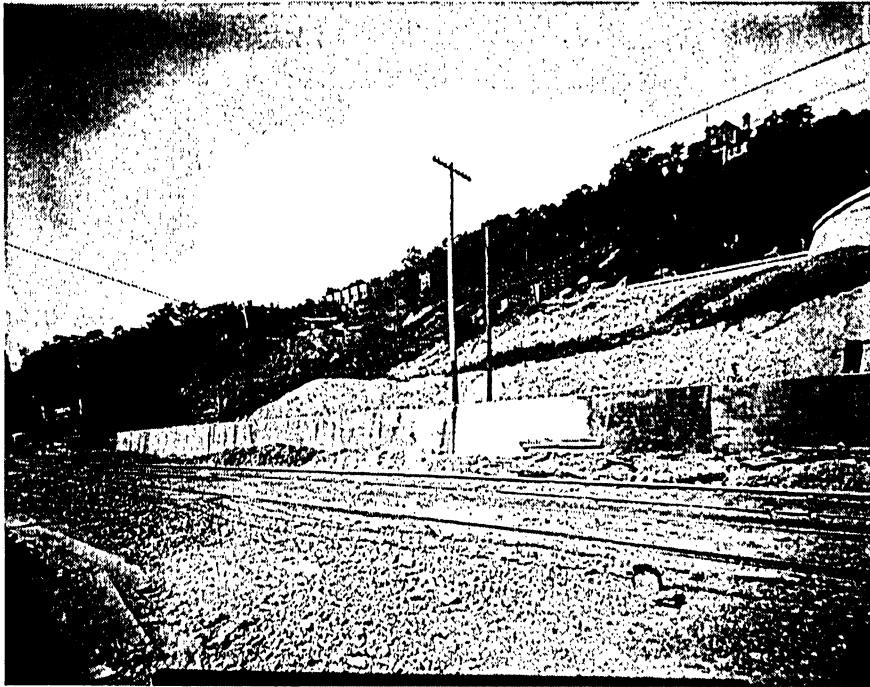
**Figure F.8** Foreground is Glenway Avenue. Upper right of photograph shows Wilder retaining wall. Photograph taken looking southwest towards the Incline. From the Cincinnati Historical Society collection.

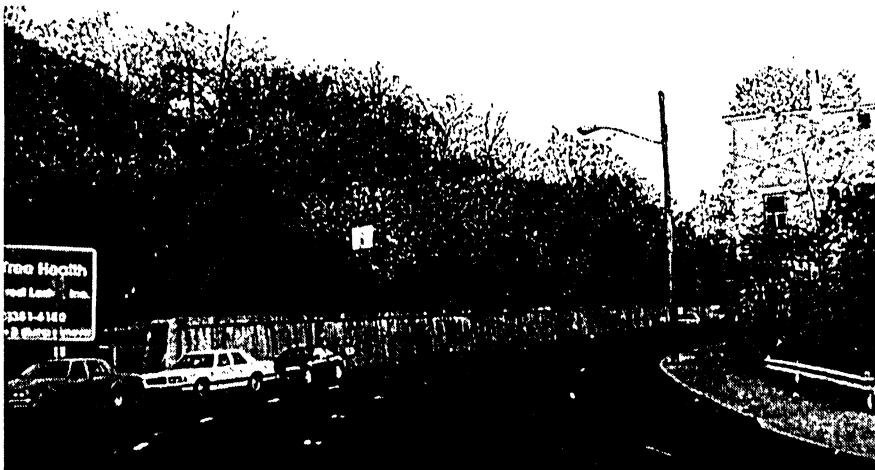
**Figure F.9** Glenway Avenue near the base of the former Incline looking northwest away from the former Incline location. Compare to Figure F.7 and F.8.

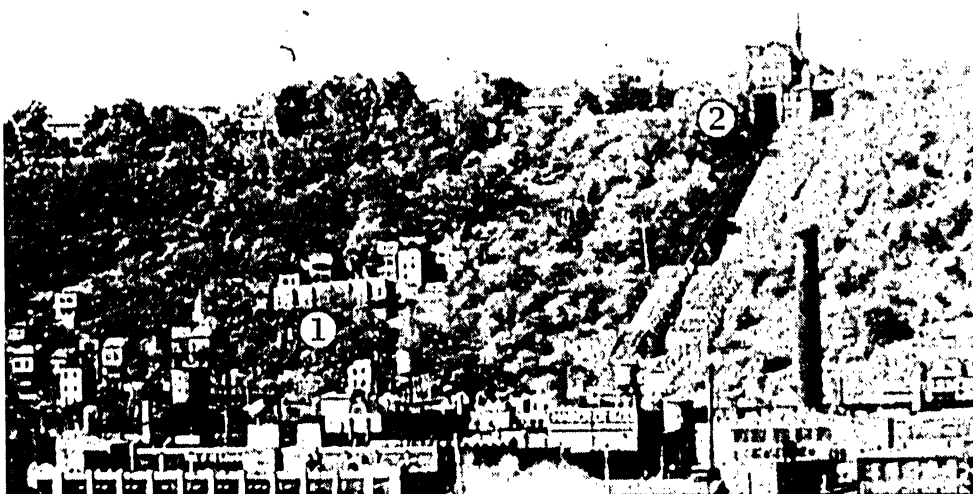
**Figure F.10** Area 1 is a buttressed limestone wall above Maryland Avenue and located below the Goforth Street terrace. Area 2 is the Incline house. Photograph courtesy of the University of Cincinnati.

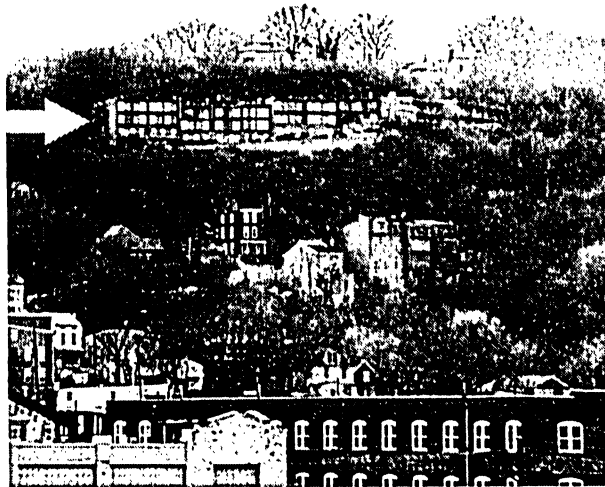
**Figure F.12** West View Condominiums (arrow) as seen from the Mill Creek Valley looking towards the west. This is the former site of a rock quarry.

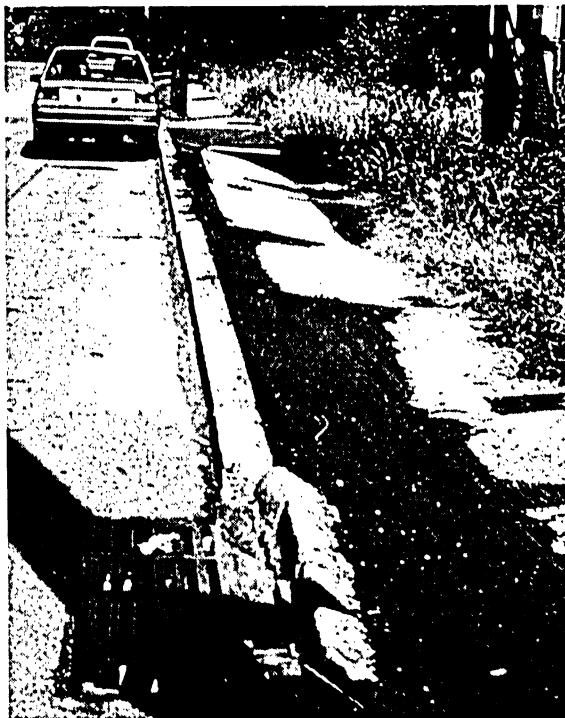
**Figure F.13** Warsaw Avenue in 1992 prior to pier wall correction project by the City of Cincinnati. Disheveled nature of the sidewalk is indicative of landsliding. The ground surface below Warsaw Avenue in this area is indistinct. Photograph courtesy of the City of Cincinnati.

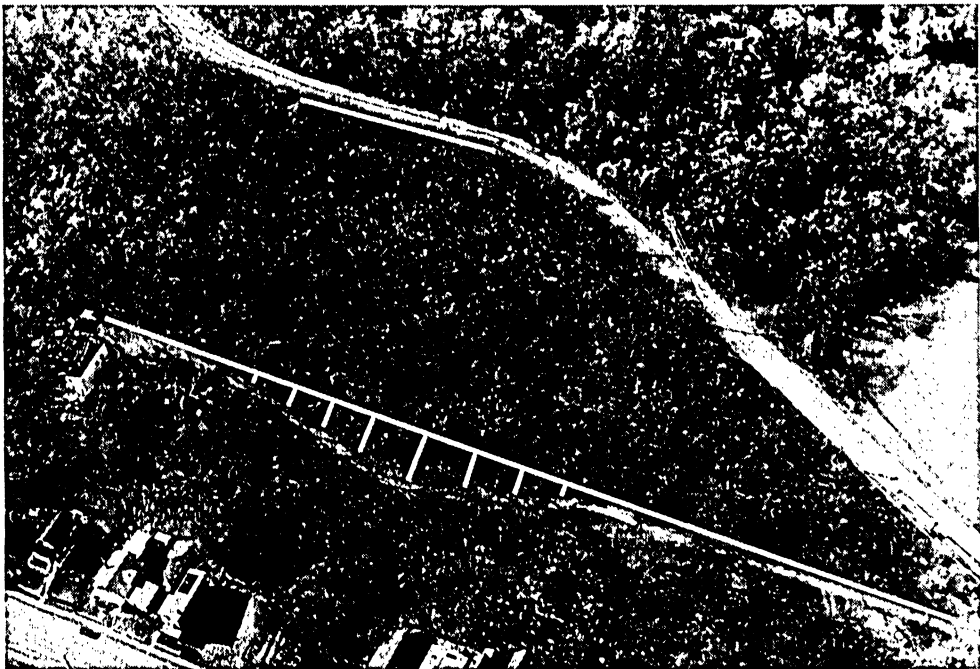
**Figure F.15** Oblique aerial photograph of Shelby Road below Lehman Road. Upper white line below Lehman Road is an area where surface water sheets over the curb and onto the hillslope. The lower white lines emphasize the bulge in Shelby Road which is a gravel road.

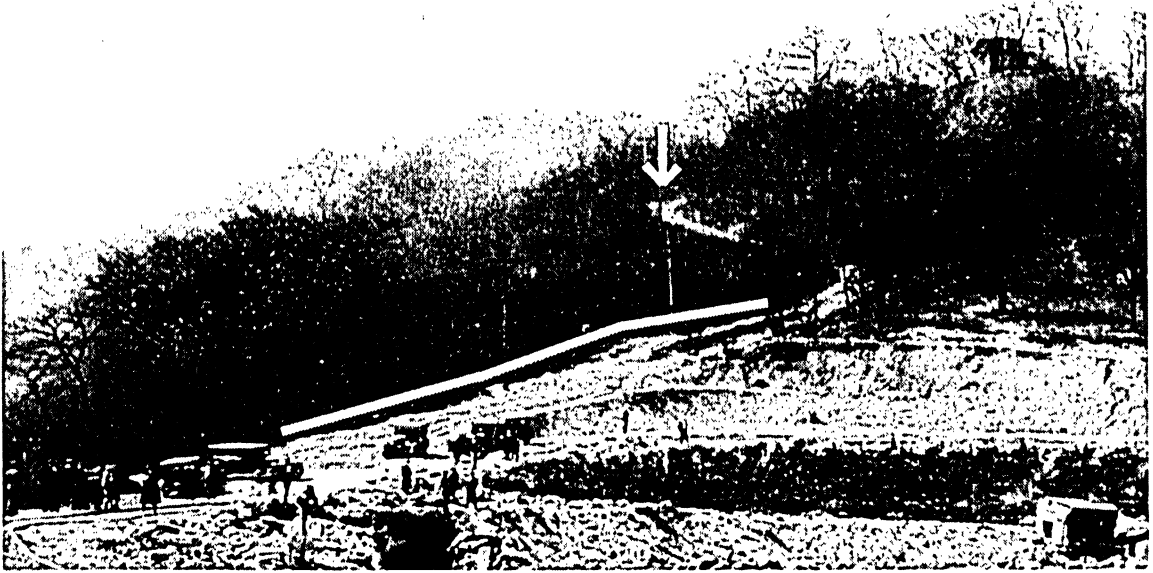
**Figure F.16** Photograph taken in 1930 looking southwest up Lehman Road (arrow). White line is above area that appears to be fill placed to widen Lehman Road. Hillslope cut in right foreground of photograph was partially filled in with uncontrolled fill in the 1980's. Photograph courtesy of the University of Cincinnati.

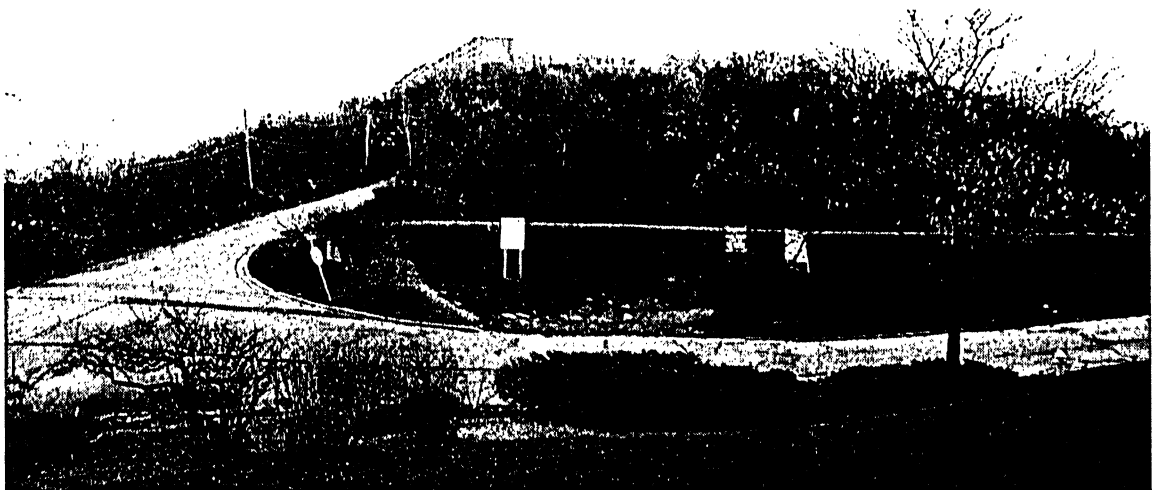
**Figure F.17** Foreground is Radcliff Drive. Road on left side of photo is Lehman Road. Level area in middle ground is uncontrolled fill placed in area excavated for the Union Terminal project. Compare to Figure F.16.

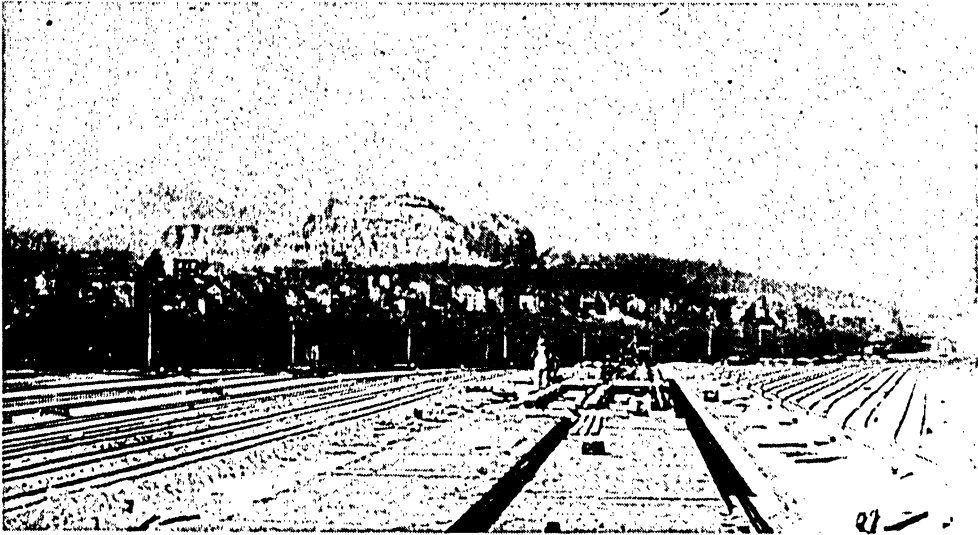
**Figure F.18** Bald Knob as viewed from the Mill Creek Valley in 1930. Bald Knob was probably worked for limestone prior to the Union Terminal project. Photograph courtesy of the University of Cincinnati.

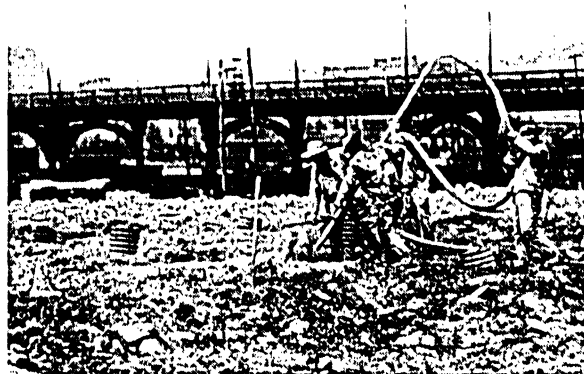
**Figure F.20** Hydrocompaction of excavated Bald Knob shale in the Mill Creek Valley. Photo courtesy of the University of Cincinnati.

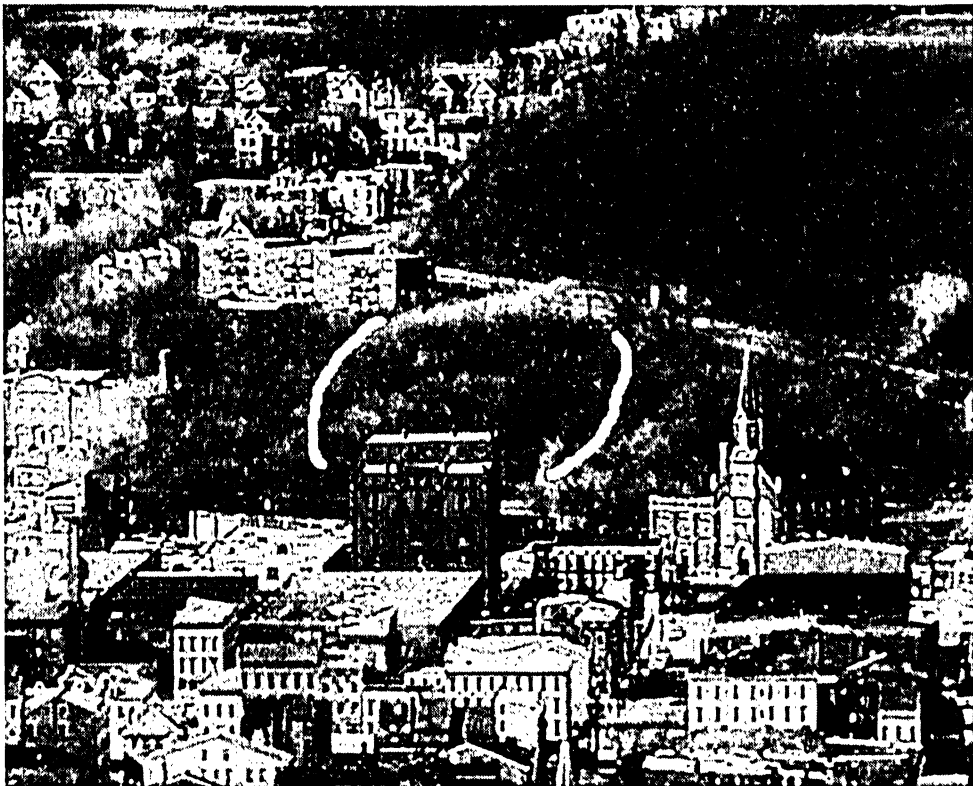
**Figure F.22** Photograph taken from the Carew Tower. White outline delineates the area of the Clifton Avenue landslide. Compare the vegetation cover on the hillslope to Figure F.21.

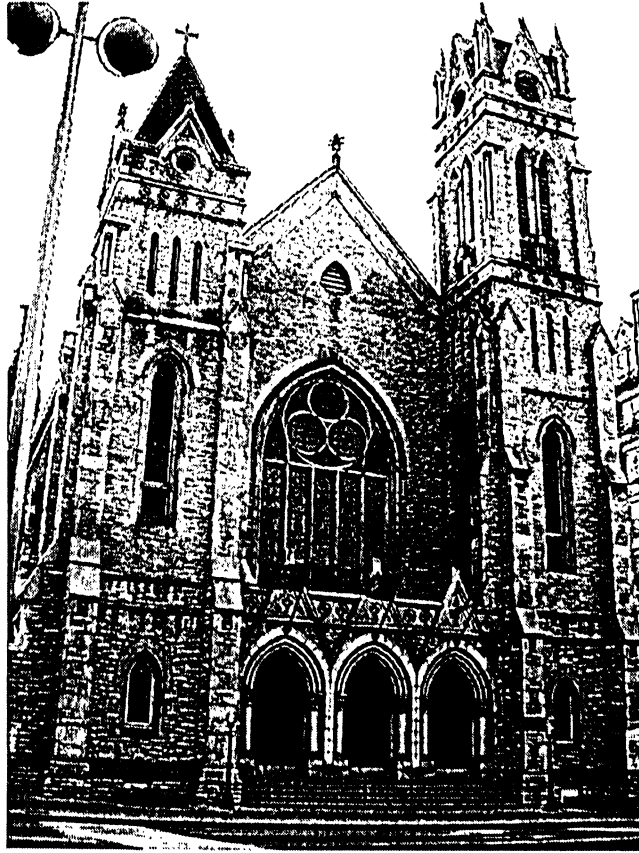
**Figure F.25** Limestone for the Covenant-First Presbyterian Church built in 1875 came from the Neff Quarry located on the Cincinnati Bible College property.

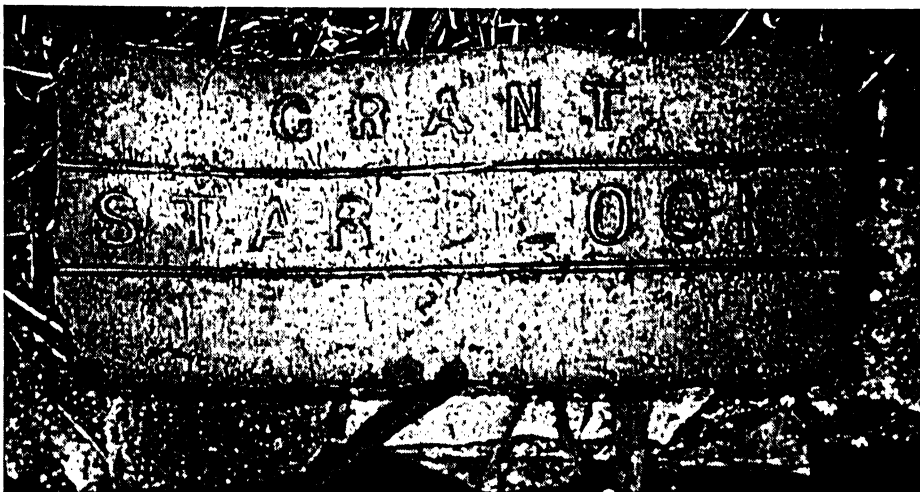
**Figure F.26** Paver brick found above Maryland Avenue on the undeveloped hillside.
